LAPORAN REPAIR KOMATSU INDONESIA

Tanggal Repair	26-Jun-23
Jam Berangkat	08.10 WIB
Jam Repair	10.30 S/D 15.30
Jam Kembali	18.00 WIB
Qty Unit Repair	30 pcs
Assy No	-
Type Unit	PC135F-10MO
Jumlah Man Power	1 Orang
Driver	-
Methode Repair	Potong Wire ganti terminal dan pasang connector

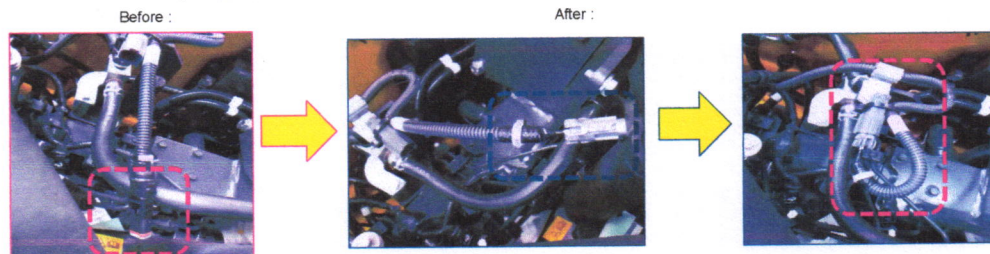
1. Modif harness PC135F pada posisi AC03 dari connector DT connector 7123-6214-40 sebanyak 30 pcs
