LAPORAN REPAIR KOMATSU INDONESIA

1. Modif wire harness PC210 HARVESTER 3 unit

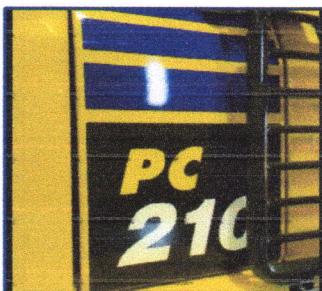
After :

Tanggal Repair	13-Oct-23
Jam Berangkat	09.45 WIB
Jam Repair	13.05 S/D 16.25 WIB
Jam Kembali	19.10 WIB
Qty Unit Repair	3 pcs
Assy No	-
Type Unit	PC210 HARVESTER
Jumlah Man Power	1 Orang
Driver	-
Methode Repair	Potong Wire ganti terminal dan pasang connector
