LAPORAN REPAIR KOMATSU INDONESIA

Tanggal Repair	19-Oct-23
Jam Berangkat	08.40 WIB
Jam Repair	11.05 S/D 16.50
Jam Kembali	19.05 WIB
Qty Unit Repair	39 pcs
Assy No	22150615-00
Type Unit	PC135F-10M0 dan PC210
Jumlah Man Power	1 Orang
Driver	-
Methode Repair	Potong Wire ganti terminal dan pasang connector

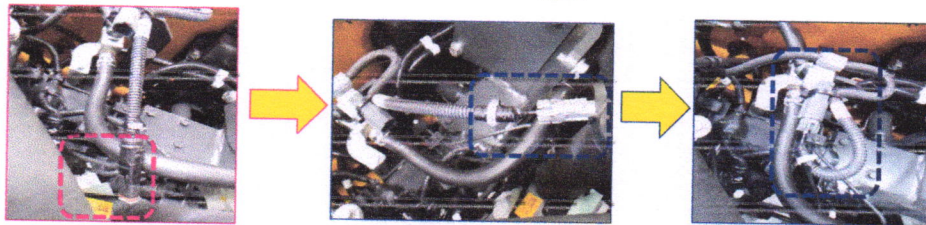
1. Modif harness PC135F pada posisi AC03 dari connector DT ke connector 7123-6214-40 sebanyak 36 pcs

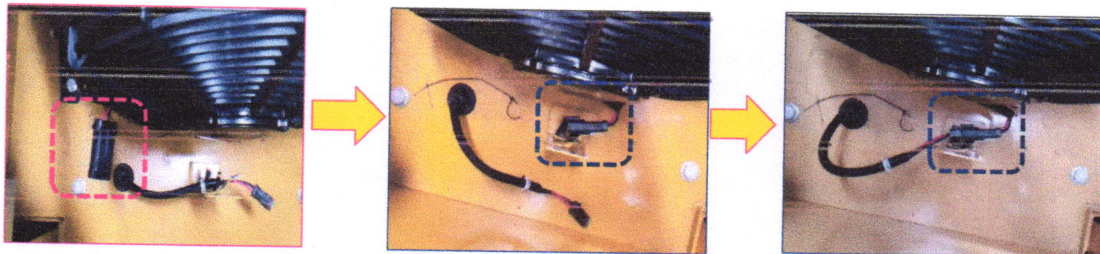
Before :

2. Modif connector untuk Oil Cooler PC210 HARVESTER sebanyak 3 pcs
