LAPORAN REPAIR KOMATSU INDONESIA

Tanggal Repair	22-Mar-24
Jam Berangkat	07.45 WIB
Jam Repair	11.20 s/d 15.55
Jam Kembali	19.50 WIB
Qty Unit Repair	3 pcs
Type Unit	PC 135 HARVESTER dan D85
Jumlah Man Power	2 Orang
Driver	-
Methode Repair	Potong wire ganti terminal dan pasang conector

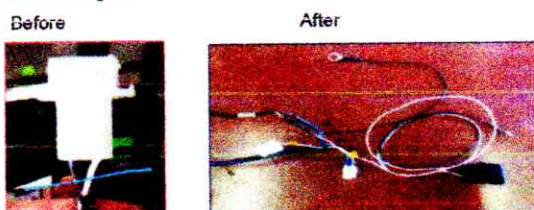
1. Modif PC 135 HARVESTER sebanyak 2 unit

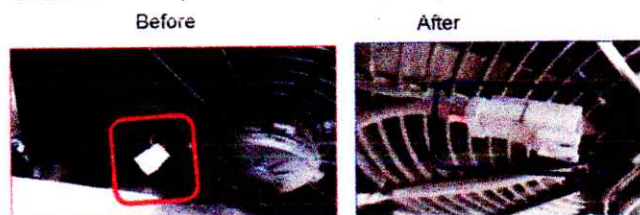
2. Sambung wire

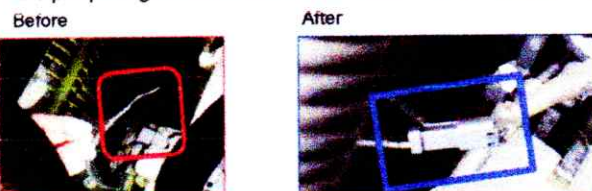
3. Modif connector pada Oil Cooler sebanyak 2 pcs
