LAPORAN REPAIR KOMATSU INDONESIA

Tanggal Repair	24-Jul-23
Jam Berangkat	08.10 WIB
Jam Repair	10.30 S/D 15.30
Jam Kembali	17.50 WIB
Qty Unit Repair	26 pcs
Assy No	14X06J1150-00
Type Unit	D85ESS-2 dan PC135F-10M0
Jumlah Man Power	1 Orang
Driver	1 Orang
Methode Repair	Potong Wire ganti terminal dan pasang connector

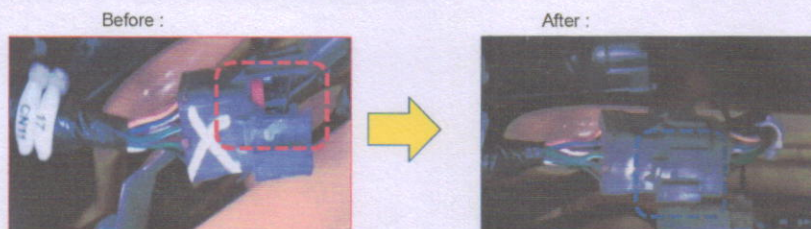
1.Modif harness PC135F pada posisi AC03 dari connector DT ke connector 7123-6214-40 sebanyak 25 pcs

2.Ganti connector di assy 14X06J1150-00 posisi CN11
