LAPORAN REPAIR KOMATSU INDONESIA

Tanggal Repair	31-Oct-23
Jam Berangkat	11.00 WIB
Jam Repair	13.05 s/d 15.50 WIB
Jam Kembali	18.15 WIB
Qty Unit Repair	1 pcs
Assy No	
Type Unit	HD785-7
Jumlah Man Power	1 Orang
Driver	1 Orang
Methode Repair	Repair ganti connector

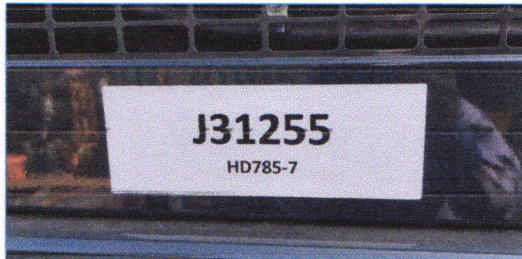
1.Repair ganti connector HD34-24-31PE pada unit HD785-7 karena NG seal mundur
Before :
