Inspection Report

Property Address:
4232 Maplehurst Road
Virginia Beach VA 23462

Keff/Spec LLC

Date: 2/22/2026	Time: 10:00 AM	Report ID: 6628
Property: 4232 Maplehurst Road Virginia Beach VA 23462	Customer: Jasmin Malanzo	Real Estate Professional: Karen Archbell Rose & Womble

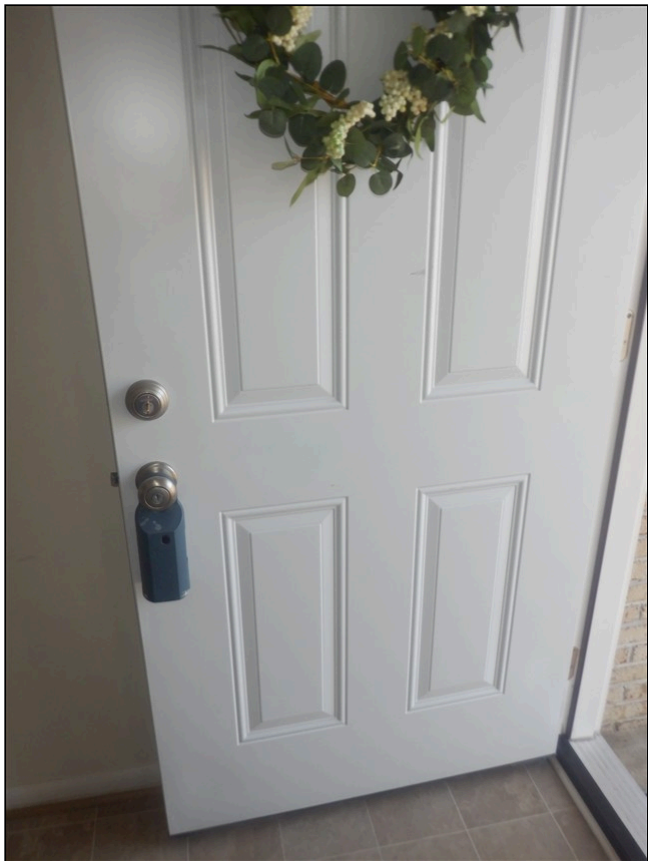
2.1 Item 1(Picture)

(1) The main entry door and trim/brick mold/frame are only factory primed, paint is needed . This/ these are/is considered a maintenance issue. A qualified person should repair or replace as needed.

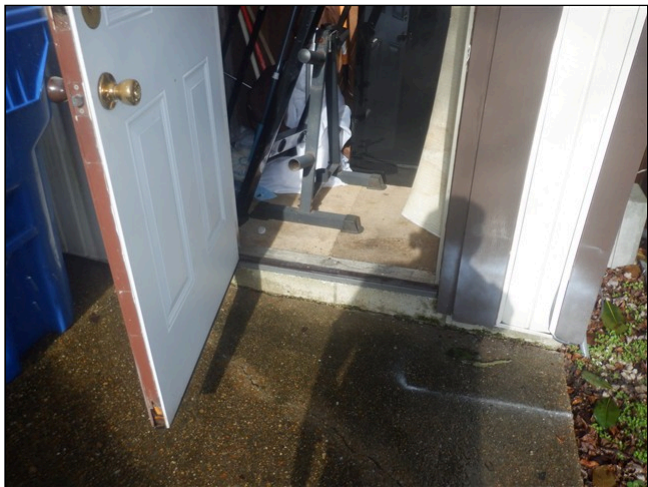
2.1 Item 4(Picture)

(2) The entry door at storage closet and/or trim/brick mold/frame is/are deteriorated from water infiltration. . A qualified contractor should inspect and repair as needed.

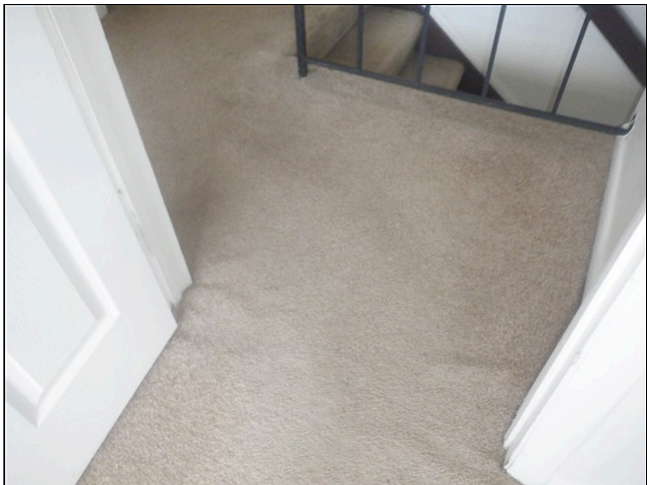
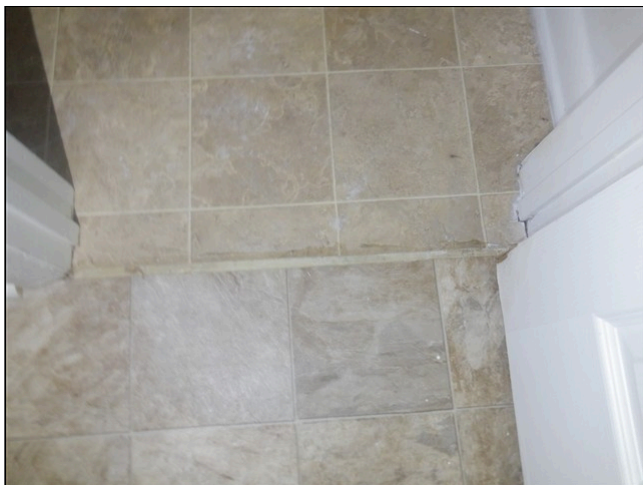
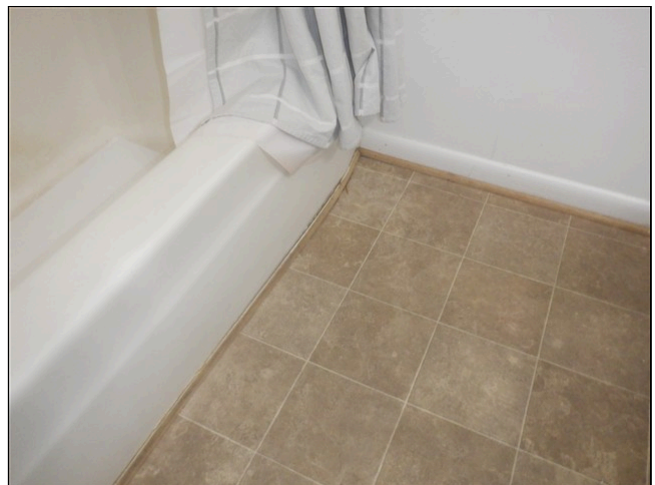
The Floor covering(s), Carpet and/or Vinyl is loose or baggy and not stretched for a tight installation and/or is/are in less than fair condition at the throughout the home. This is a cosmetic issue for your information. A qualified contractor should inspect and repair as needed.

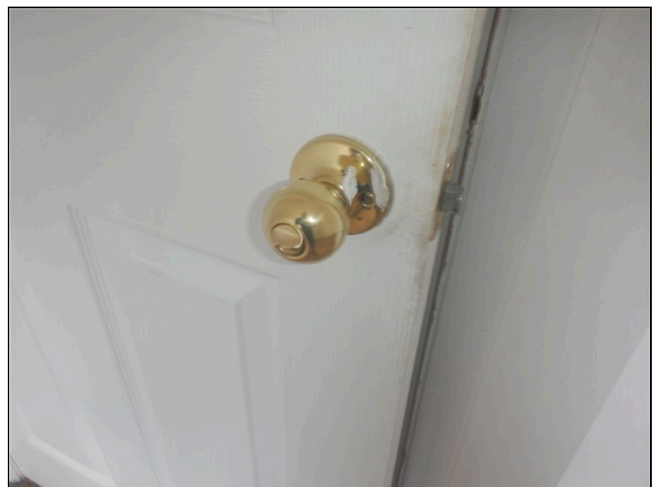
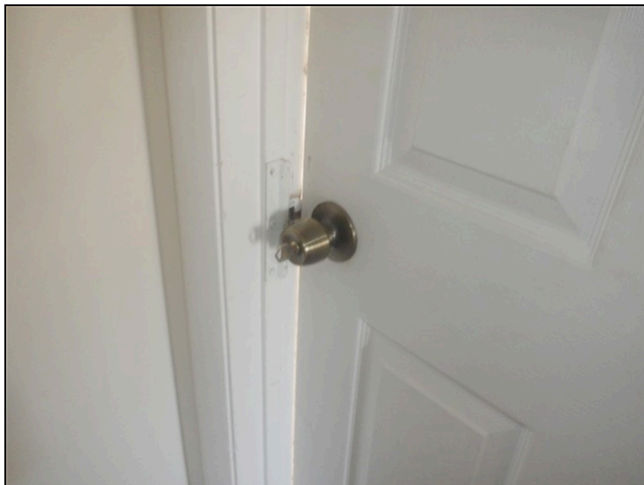
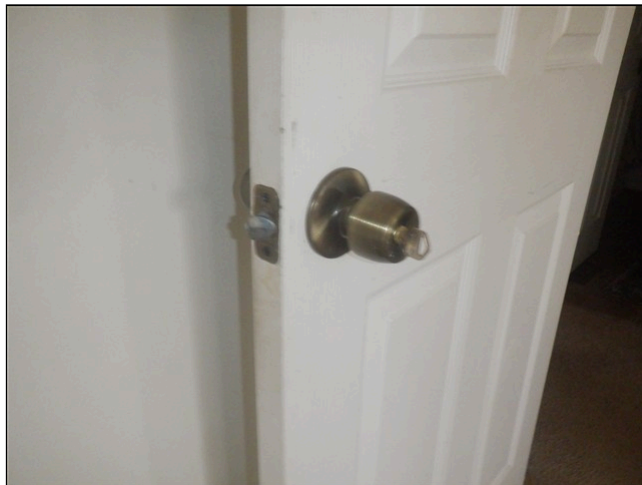
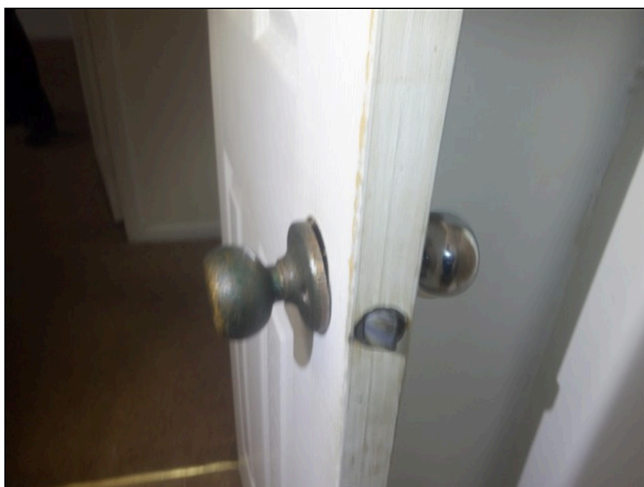
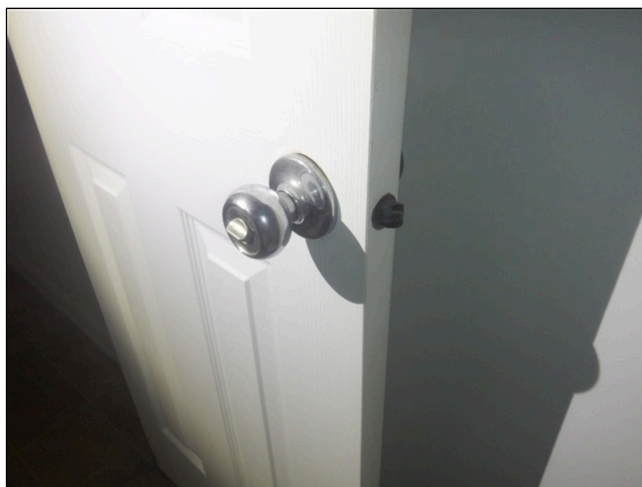
(1) Several closet and entry doors knob(s) is/are loose and/or have/has locking or keyed locking knob(s) installed where not permitted throughout the home. . A qualified contractor should inspect and repair as needed.

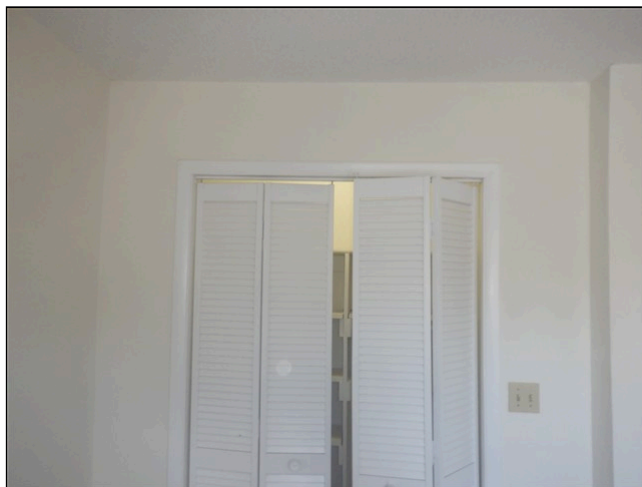
3.5 Item 7(Picture)

(2) Bi-fold door is/are damaged at the utility room. . A qualified contractor should inspect and repair as needed.

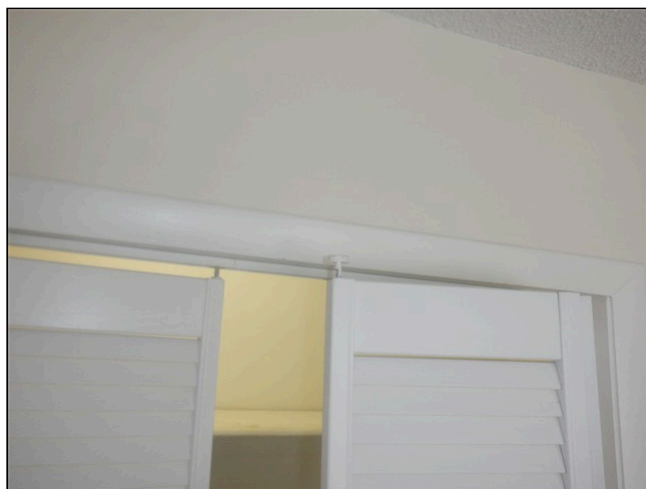
(3) Bi-fold door falls out of track when opened at the front left bedroom. This/these are/is considered a maintenance issue. A qualified person should repair or replace as needed.

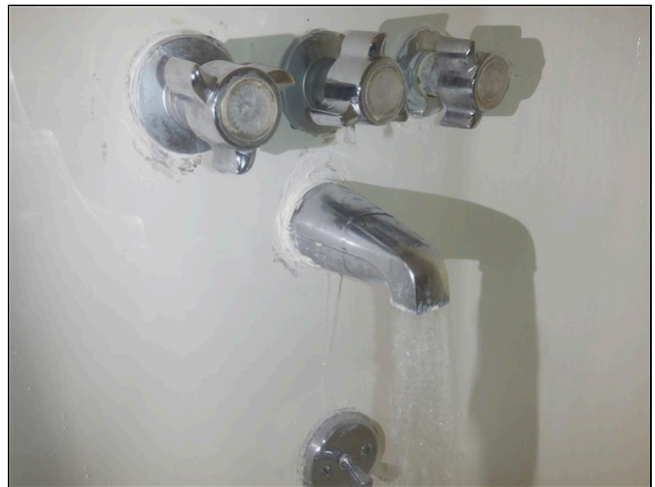
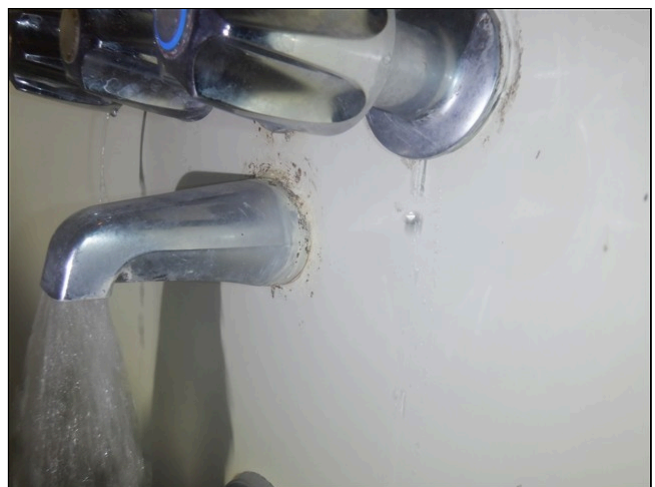
(2) The All three shower/tub water controls; Hot ,Cold , and Diverter leak(s) behind handle when the water is turned on and show signs of inadequate repairs at the hall bath and primary bath. Repair(s) are needed. A qualified licensed plumber should repair or correct as needed.

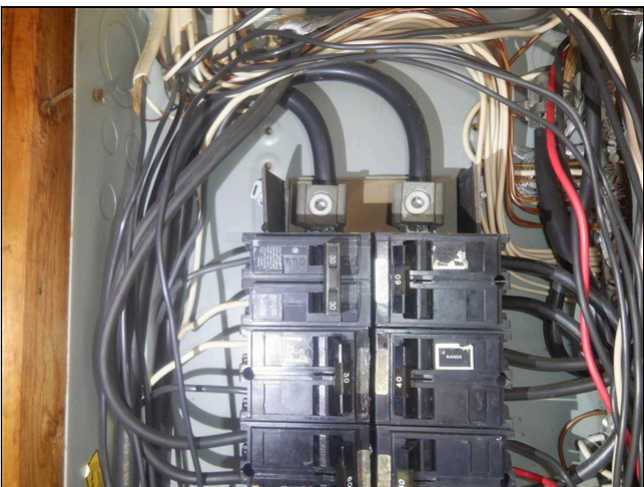
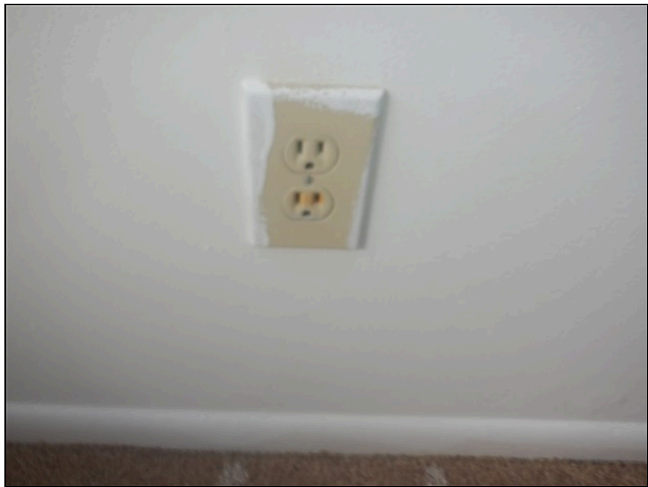
The problem(s) discovered in the panel such as breaker(s) are different brands, and/or do not match the manufacture of panel, circuits not fully, properly or clearly labeled or identified, cover missing screws, and any other problems that an electrical contractor may discover while performing repairs need correcting. I recommend a licensed electrical contractor inspect further and correct as needed.

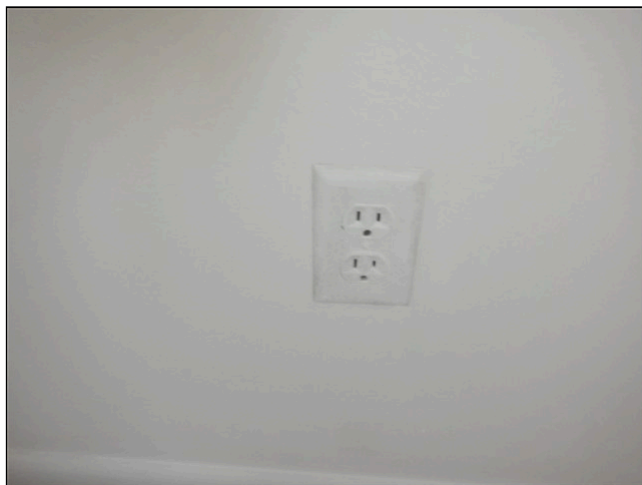
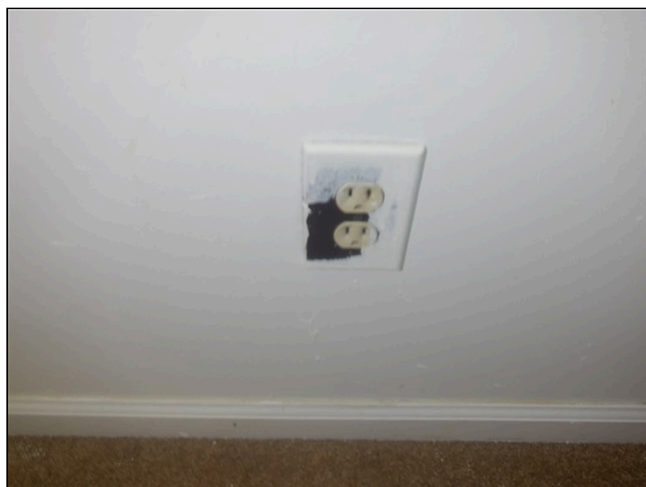
6.3 (1) Several switches and 3 prong outlets are loose in wall and need to be tightened, old and contacts are loose and no longer holds plug securely, clogged or obstructed with paint, and/or damaged/burnt throughout the home. Electrical issues are considered a hazard until repaired. A

qualified licensed electrical contractor should perform repairs that involve wiring.
