NASA TECHNICAL NOTE

NASA TN D-7780

APOLLO EXPERIENCE REPORT - SPACECRAFT STRUCTURE SUBSYSTEM

by P. D. Smith

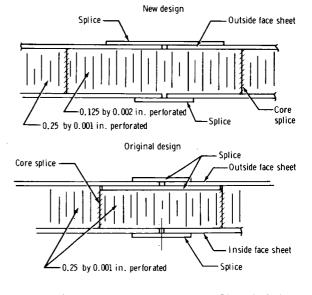
Figure 21. - Honeycomb splice joint.

The findings of the various reviews and studies were that no basic weakness existed in the SLA design and that the SLA loads at the time of the anomaly were less than those demonstrated in the ground test program. When the anomaly occurred, two independent pressure transducers registered pressure drops indicating a hole or holes had opened in the spacecraft. The suspected holes, the shift in instrument readings, and the photographs of objects falling from the SLA led investigators to the conclusion that portions of the SLA honeycomb panels had failed and had fallen from the spacecraft. It was also concluded that because the designed structural capability of the SLA was more than adequate for the flight loads experienced, the failure occurred because of an undetected manufacturing defect. One possible cause of the failure was separation of face sheets from the honeycomb core because entrapped moisture in the honeycomb cells became heated during boost, thereby increasing the pressure inside the cells until the face sheets were blown off.

Although the cause of the Apollo 6 structural anomaly could not be determined conclusively, the most likely causes have been eliminated. The inspection records of each SLA after SLA-9 have been thoroughly reanalyzed, and the aforementioned modifications have been implemented to provide confidence in the flightworthiness of each SLA. No SLA structural anomalies have occurred since the Apollo 6 flight.

alined. This provided a clear area for ultrasonic and radiographic inspection and made interpretation of these inspections much easier and more accurate. This redesign was implemented on SLA-22 and each subsequent SLA; all other SLA panels had been manufactured at that time. The redesign was considered a product improvement and not a mandatory design change.

The experiences associated with this anomaly indicate that, in the design of honeycomb panel structures, avoiding overlapping edges and splices and making the structure easy to inspect should be strong design considerations. The possible detrimental effects of entrapped moisture in honeycomb core cells should also be considered.
