EK | Team 103 | JLCDFM Results

Uploaded EK103.zip | 2 copper layers | 80 x 65 mm | 20 October 2026

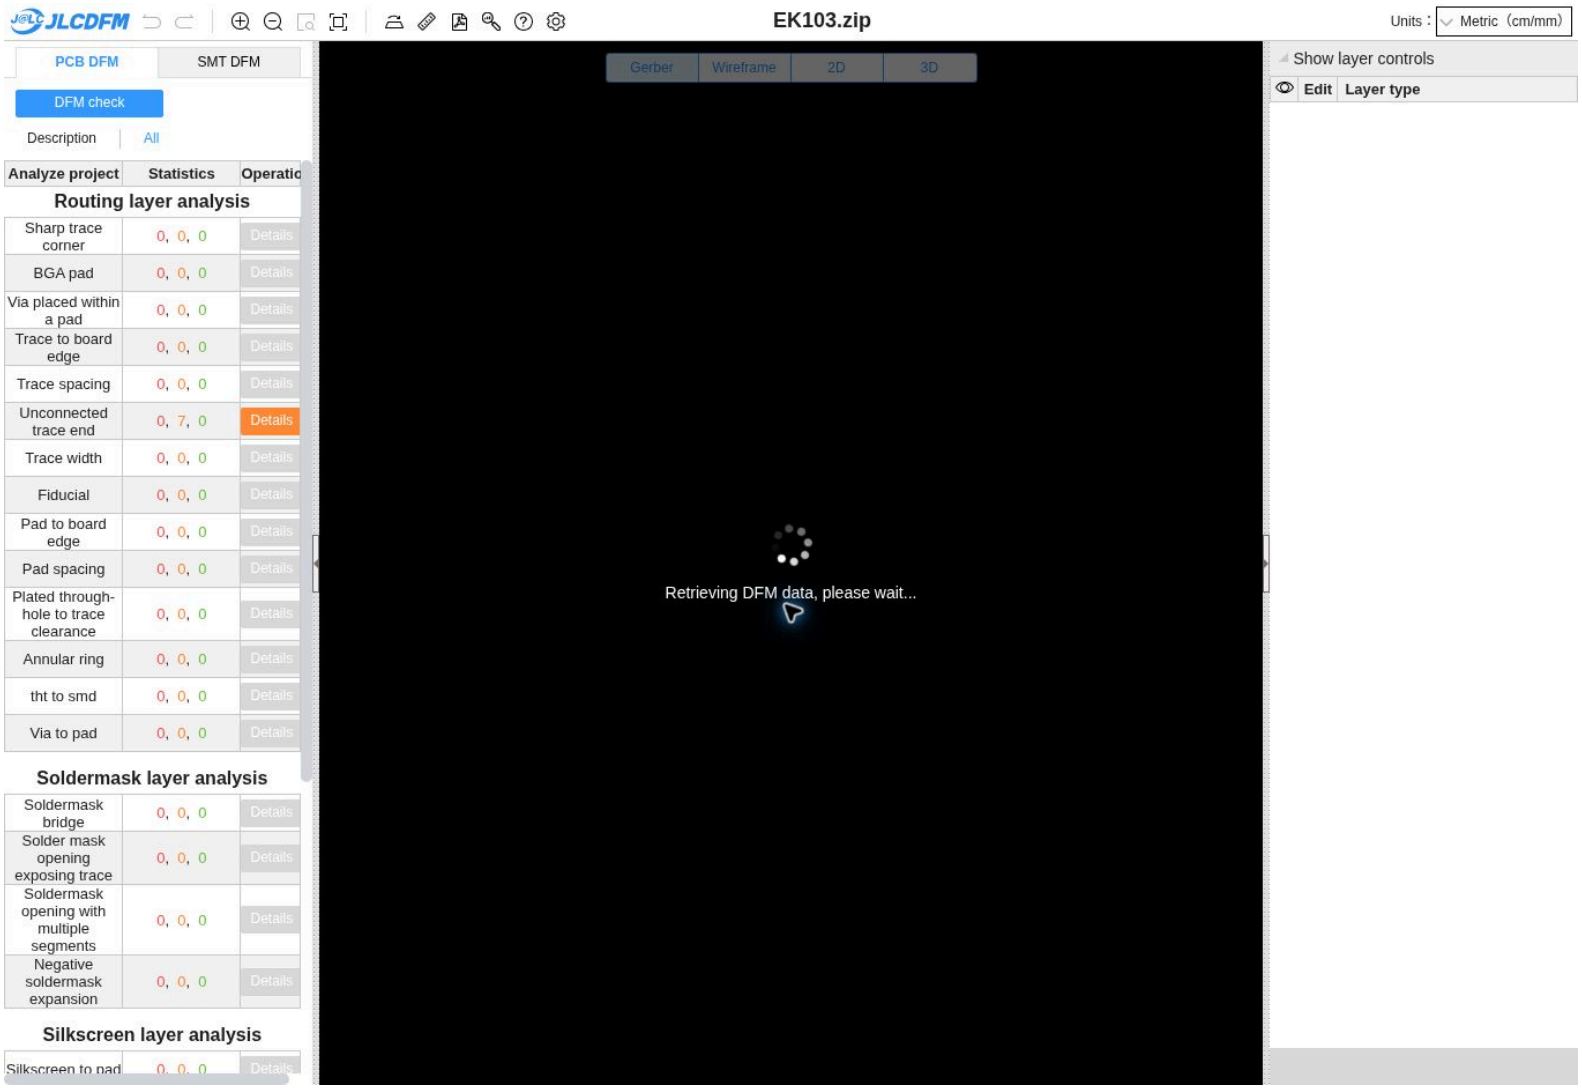
0 danger findings

7 warnings

All seven warnings:
Unconnected trace end
Top.art

The site listed each object as r39.3701. This corresponds to a 1.0 mm stroke.

The Gerber contains seven 1.0 mm line segments forming the required EK copper lettering. This is a likely explanation, not a location-verified dismissal.

Actual JLCDFM screenshot, unchanged. Analysis completed and results persisted after reload. The geometric viewer remained on "Retrieving DFM data" and the site PDF export stalled, so detailed location confirmation and a native JLCDFM PDF could not be obtained. This document captures the observed results and does not claim a warning-free pass.
