Smart Meter Installation www.thermoguy.com

## **Smart Meter Installations & Fires**

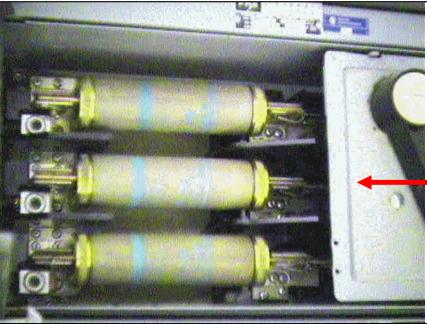
## **Stab Connection Example for Smart Meter Fires**

This is highlighting a loose or corroded **stab** connection in a fused disconnect. Stabs are used to connect the electrical meter to the meter base.

The arrows are highlighting the stab connection where the one side is 140 degrees C hotter than the other side because of the connection. As in a building with a Smart Meter, more electrical demand, more appliance use, AC use or devices plugged in accelerates electrical failure.

Look at the digital picture of the fused disconnect and to the untrained eye there appears to be no problem. That is the importance of qualified electrical professionals with required permits to install electrical meters.

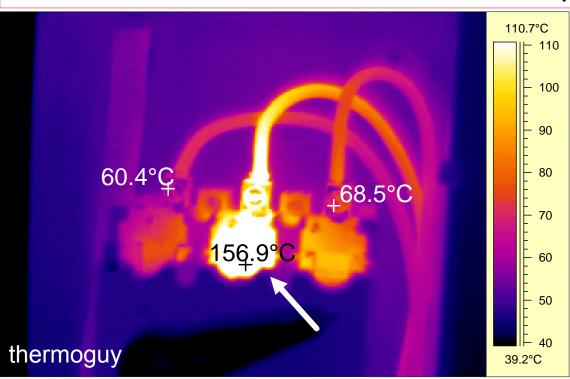
## **Wired Connections For Smart Meter Example**

In the electrical example above, a faulty wired connection welded in a closed position so they couldn't turn the switch off. It required changing the disconnect or there would have been electrical failure resulting in explosion, fire or both.

An unqualified professional wouldn't know how to address the problem. The arrow is highlighting discoloration associated with heat.

Electrical Meter Bases have wired connections as well as stabs. Qualified electrical professionals would check ALL connections when the meter is pulled.(safely and working with the home owner) Before installing the new meter any electrical problems would be identified and repaired, even replacing the meter based if required. There are no compromises electrically or there will be failure with consequences including fires.
