Australian Antarctic Division

Asbestos Register
Mawson Station

File [RM8] Ref: CD14/43 [v5]	**Responsible Officer**: Infrastructure Engineer	**Authorising Officer**: General Manager Support and Operations	**Authorisation Date**: 07/12/2018
Version Number: 5			**Reviewed Date**: 16/06/2021
Location of Hard Copies/Points of Use: Antarctic Infrastructure Kingston, Mawson Station

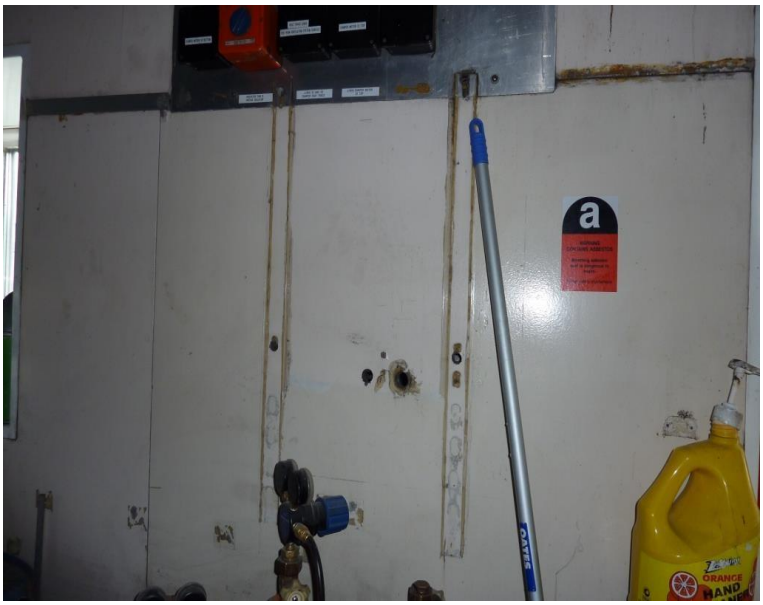
L123003	Cosray Building vault room lining.	
L123004	Cosray Building exterior foundations. *Note, there are several footings under Cosray with encapsulated asbestos.	
L187401	Dog Hut external cladding.

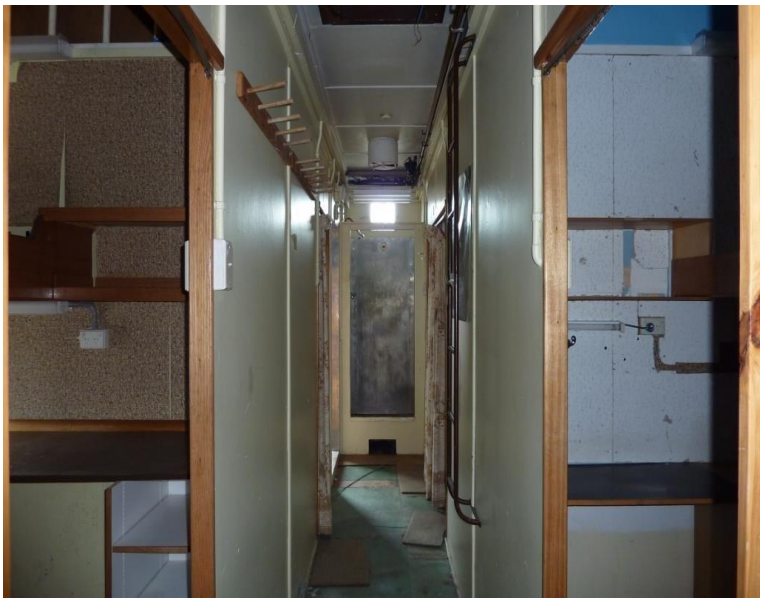
L117309	Sleeping and Medical Quarters ground floor fire doors.
