Group #07

Bridge-00

18g, 1700N

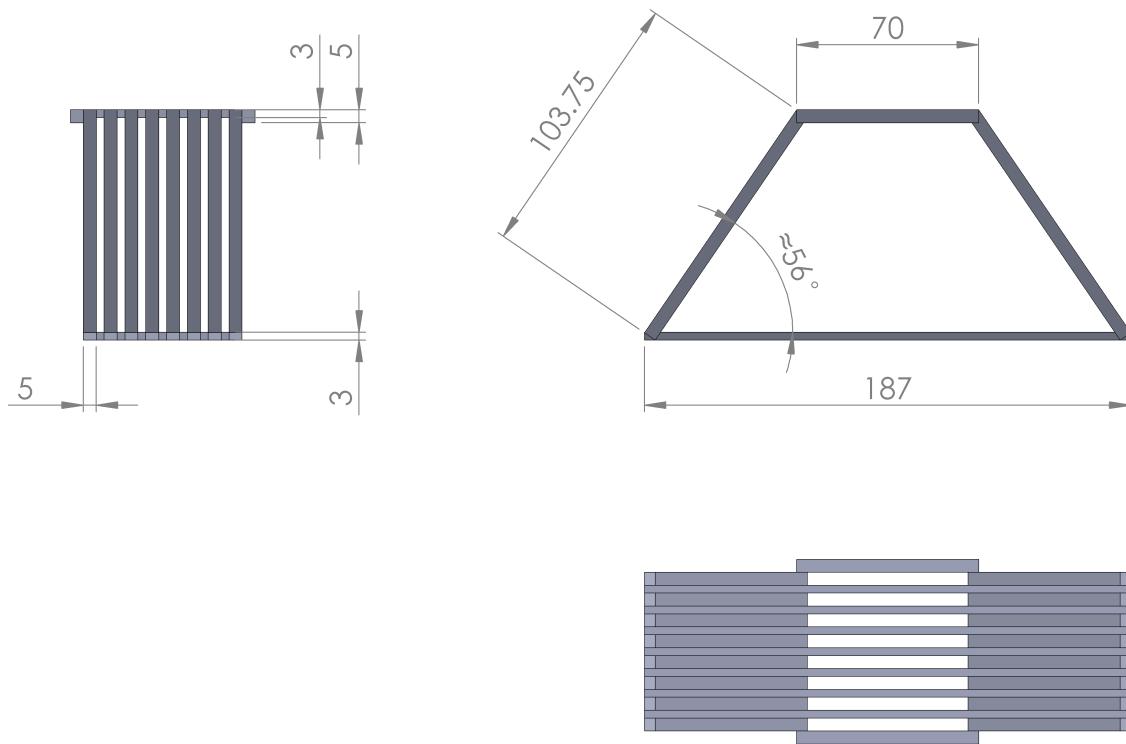
Figure 1: Dimensioned drawing.

Final bridge design can be seen in Figures 1 and 2.

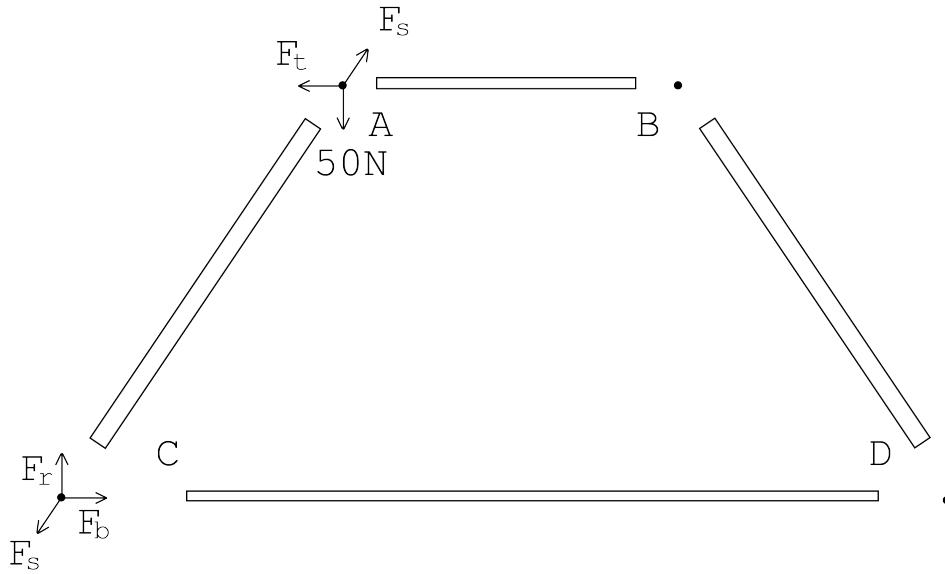
Due to the unconventional design, to ease the calculations during the analysis, it was assumed that the load is equally distributed between eight trapezium-shaped trusses. Thus, a single trapezium truss was analyzed, and then extended to approximate the entire bridge. Internal forces, nodes and members are labelled as per Figure 3. As the truss is symmetrical, only two nodes needed to be analyzed. For a load of 100N divided equally between nodes A and B, force equilibrium for nodes A and C are described in equation blocks 1 and 2 respectively.

Figure 3: Trapezium truss.

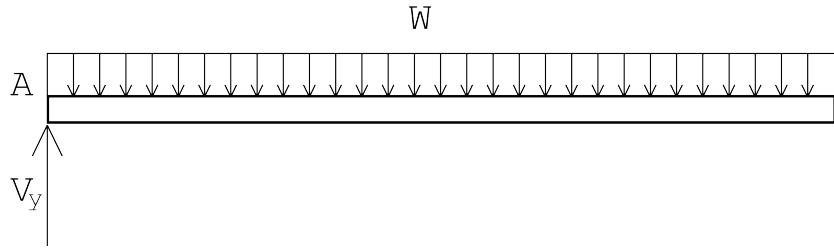
Figure 4: Half of the top joint row under load.

Now the internal forces in this rigid body can be analysed using the distributed load and the support reactions. Figure 4 shows the distributed load  $w(\text{N/m})$  on the unsupported segment and hypothetical support reaction  $A_y$  under an arbitrary load. The intensity of the distributed load is given by the total loading applied by the loading plate divided by  $0.14\text{m}$ , the combined lengths of the two lines of joints. The equation for the internal shear force along the line of joints is:  $V = A_ywx$  where  $x$  is the distance from point A and  $V$  is the internal shear force. This equation shows that the internal shear force is maximum at point A ( $x = 0$ ) which is where the break occurred. The equation for the internal moment is  $M = A_yx0.5(wx^2)$ , where  $M$  is the internal moment.  $M$  is maximum at  $x = 0.035$  or the furthest point along the body from A. In reality the moment may be reduced slightly as the structure may bend to compensate for the
