DRONE DAMAGE INSPECTION REPORT

DRONE-89757012

Address: 13901 Southview

Inspection Date: 2026-02-11

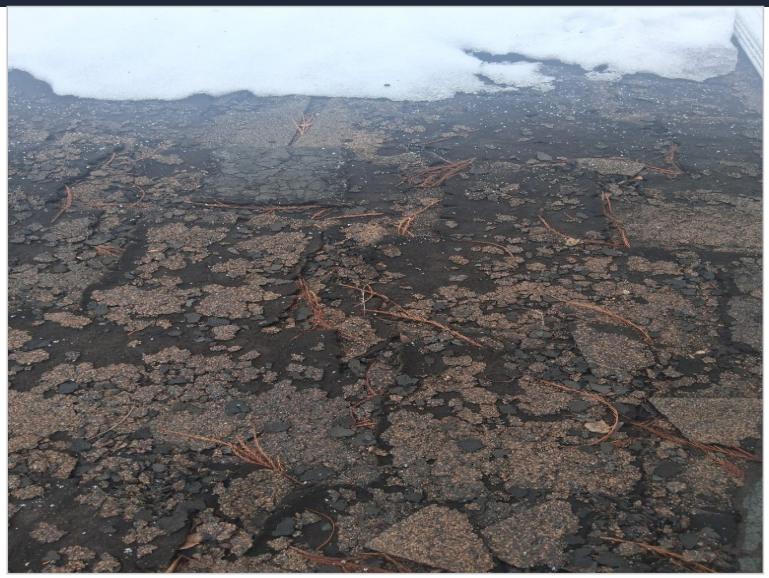
Severity: MODERATE

The roof appears to have some surface wear, with visible granule loss and debris accumulation. There are no major missing shingles or significant structural damage. Overall, while the roof is intact, its condition indicates moderate wear and may need attention to prevent further deterioration.
