Structural Damage Claim Policy

Insured:	POPE, MARY	Estimate:	35-95Z3-96MR
Property:	13901 SOUTHVIEW AVE CLEVELAND, OH 44120-4655	Claim Number:	3595Z396M
		Policy Number:	70EM31717
Home:	216-991-0645	Price List:	OHCL28_NOV25 Restoration/Service/Remodel
Type of Loss:	Wind		
Deductible:	$500.00		
Date of Loss:	11/20/2025		
Date Inspected:	2/10/2026

Summary for Coverage A - Dwelling - 35 Windstorm and Hail

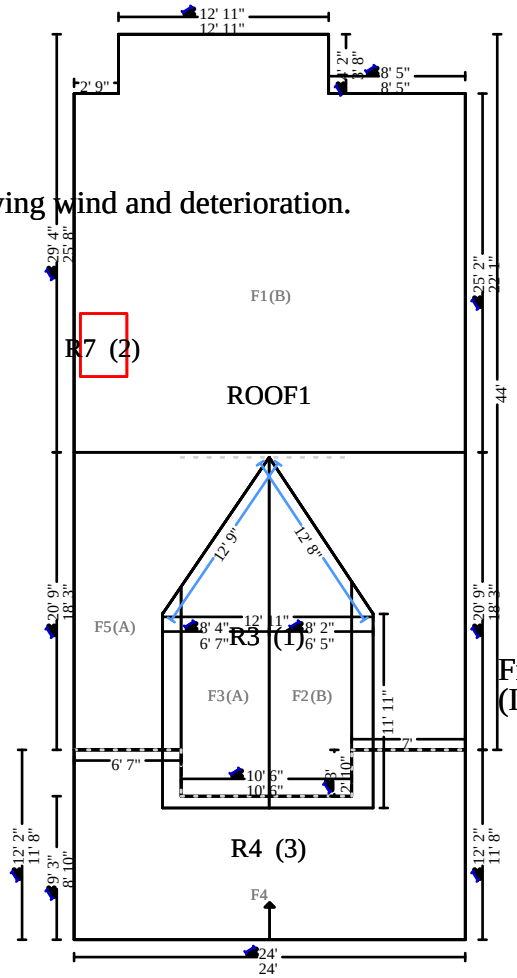
Back slope (R1) of the house showing wind and deterioration.

Front slope (R3&R4) of the house shows wind and deterioration. (Includes F2, F3, F4, & F5)

DESCRIPTION	QUANTITY	UNIT PRICE	TAX	RCV
1. Tear off, haul and dispose of comp. shingles - 3 tab	15.25 SQ	76.54	0.00	1,167.24
2. 3 tab - 25 yr. - comp. shingle roofing - w/out felt	17.00 SQ	262.29	148.20	4,607.13
Component RFG240 from this line item was priced by ITEL Asphalt Shingle Pricing (ASP) on 16 Feb 2026. Auto Calculate(Not available)
