Your Insurance Claims Network
675 Alpha Dr. Suite E&K, Highland Heights, OH 44143
216 331 8323
5/12/2026 2:33 PM

Insured:	FLOYD BREAZEALE	Estimate:	FLOYD BREAZE2
Property:	13720 BANGOR AVE GARFIELD HTS, OH 44125-6003	Claim Number:	3598C944L
		Policy Number:	35GJR1404
Home:	216-319-0275	Price List:	OHCL28_MAR26 Restoration/Service/Remodel
Type of Loss:	Wind		
Deductible:	$0.00		
Date of Loss:	3/12/2026		
Date Inspected:	3/30/2026

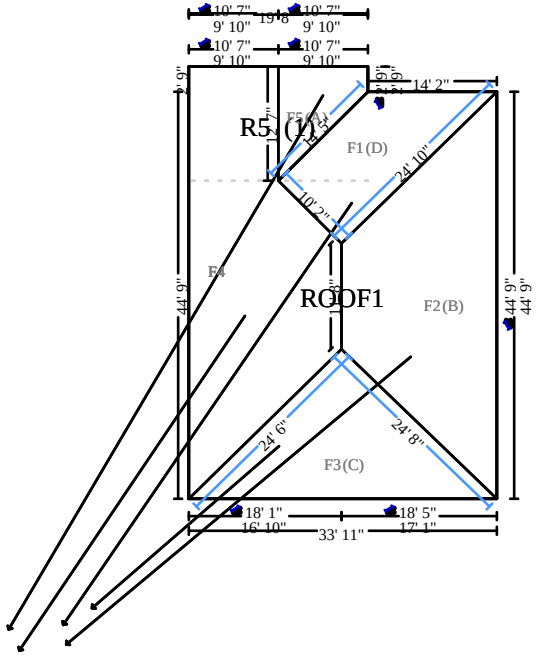
All Slopes of both main and garage roof need replacement.
The roof shingle is 3 Tab shingles - no longer available
