Investigations on degradation of the long-term proton exchange membrane water electrolysis stack

Abstract: A 9-cell proton exchange membrane (PEM) water electrolysis stack is developed and tested for 7800 h. The average degradation rate of 35.5 $\mu V\ h^{\text{--}1}$ per cell is measured. The 4th MEA of the stack is offline investigated and characterized. The electrochemical impedance spectroscopy (EIS) shows that the charge transfer resistance and ionic resistance of the cell both increase. The linear sweep scan (LSV) shows the hydrogen crossover rate of the membrane has slight increase. The electron probe x-ray microanalyze (EPMA) illustrates further that Ca, Cu and Fe elements distribute in the membrane and catalyst layers of the catalyst-coated membranes (CCMs). The cations occupy the ion exchange sites of the Nafion polymer electrolyte in the catalyst layers and membrane, which results in the increase in the anode and the cathode overpotentials. The metallic impurities originate mainly from the feed water and the components of the electrolysis unit. Fortunately, the degradation was reversible and can be almost recovered to the initial performance by using 0.5 M H₂SO₄. This i

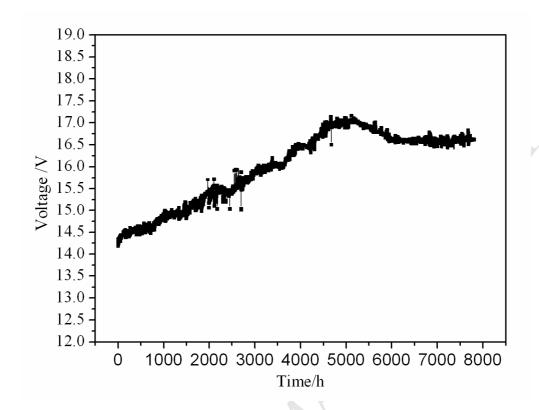
Fig.2

The experiments were performed to investigate the stability of a 9-cell PEM stack for 7800 h. The measured voltage of the stack varying with running time is shown in Fig. 2. According to Fig.2, the voltage curve can be approximately divided into four regions. In

first region of 0-4805 h, the voltage increases gradually from 14.16 V to maximum value 17.07 V, the fit curve illustrates the degradation rate is 0.589 mV h⁻¹. In second region of 4805-5094 h, the voltage nearly keeps stable. Whereas, in third region of 5094 -6075 h, the voltage dramatically decreases from 17.05 V to 16.55 V in the rate of 0.512 mV h⁻¹, suggesting the enhanced cell performace. At last, the electrolysis voltage almost levels off (ca. 16.65 V). The average degradation rate of the individual cell voltage is around 35.5 μ V h⁻¹ during 7800 h life. In order to understand the observed degradation of stack performance, the 4th MEA was offline analyzed.

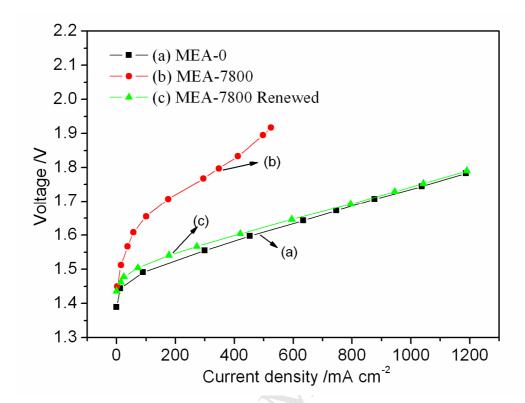
Fig. 3

As can be seen from Fig. 3, *I-V* curves of MEA-0, MEA -7800 and MEA -7800 Renewed were investigated. The performance of MEA -7800 is obviously worse than that of MEA-0 and MEA -7800 Renewed, the voltage increases from initial 1.61 V to 1.897 V at 0.5 A cm⁻² after 7800 h operation. After recovery treatment, MEA -7800 Renewed performs nearly as good as the fresh MEA in Fig. 3. The cell voltage recovers from 1.897 V to 1.624 V at 0.5 A cm⁻², which almost attains 99.1 % intinial performance. The result displays that the performance deterioration is reversible after 7800 h operation and can be recoveried by dilute sulfuric acid.

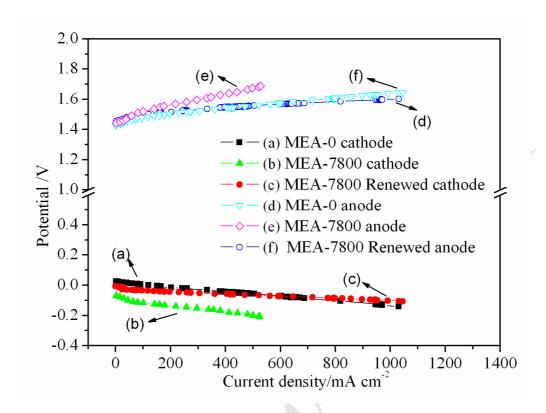
Fig. 4

To investigate the cause of performance degradation, the potential of the anode and cathode was measured, respectively. As displayed in Fig. 4, the electrode potential of MEA-7800 is visibly worse than that of MEA-0 and MEA-7800 Renewed. The cathode potential of MEA-7800 decreased from -0.06 V to -0.2 V in the range of 0-530 mA cm⁻², and its anode potential increased from 1.44 V to 1.68 V in Fig. 4b and Fig. 4e. However, the anode and cathode potentials of MEA-0 and MEA-7800 Renewed were almost uniform in the range of 0-1000 mA cm⁻², as shown in Fig. 4. The cell voltage is the

potential difference between the anode and cathode potentials. Consequently, the dramatic variations of cell voltage in Fig. 2 is mainly attributed to the change of the anode and cathode overpotentials. But the cell performance can be almost completely recovered by the treatment using 0.5 M sulfuric acid solution. Accordingly, it can be deduced that the removable contaminants have influence on the anode and cathode reaction.

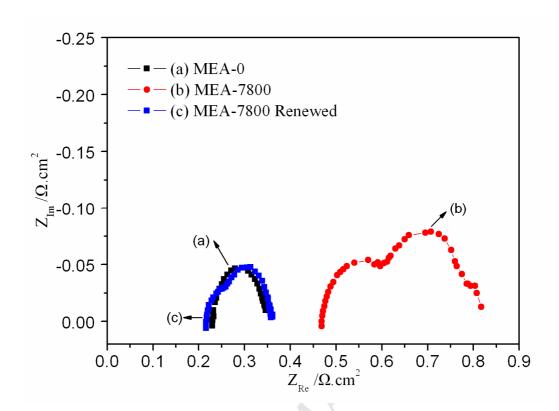
Fig.5

To get more insights into the performance degradation, the electrochemical impedance of the three electrolyzers was carried out at 1.55 V. Fig. 5 shows Nyquist plots of the three electrolyzers. The high frequency intercepting with the real axis R_{Ω} of the cell using MEA-7800, which represents the total ohmic resistance after running 7800 h, is bigger than that of MEA-0 and MEA-7800 Renewed. Moreover, the arc diameter of the cell using MEA-7800 represents charge transfer resistance R_{ct} [18], which is also bigger than that of MEA-0 and MEA-7800 Renewed. The R_{Ω} and R_{ct} can be obtained through simulation with $R_{\Omega}(R_1Q_1)$ ($R_{ct}Q_{dl}$) equivalent circuit [19] and listed in Table 1. As shown in table 1, both R_{Ω} and R_{ct} of MEA-7800 (Fig. 5 b) obviously increase, therein R_{ct} is a distinct increase than R_{Ω} , which about triples that of MEA-0 (Fig. 5 a). After recovery (Fig. 5 c), R_{Ω} and R_{ct} are decreased and almost arrive at the initial value. Based on the agglomerate model, the microstructure of the porous catalyst layer can be depicted as catalyst particles covered with Nafion polymer electrolyte [20,21]. The catalyst and electrolyte provides catalytic sites and delivery channel of protons, respectively. According to our previous works[22], impurities will not only increase ohmic resistance but also hinder protons leave or transfer to the catalytic sites, which leads to the increase in charge transfer resistance R_{ct} and the decrease in exchange current density [23,24]. We can see from Table 1, the charge transfer resistance R_{ct} accounts for 34 % in the total resistance for MEA-0, whereas it increases to 42.7 % for MEA-7800. Thus it will lower the reaction rate and increase the overpotential

at a given current density. After recovery (Fig. 5 c), more protons are available in membrane and the three phase boundary of catalyst layers. That is the very reason for the recovered performance of MEA-7800 Renewed.

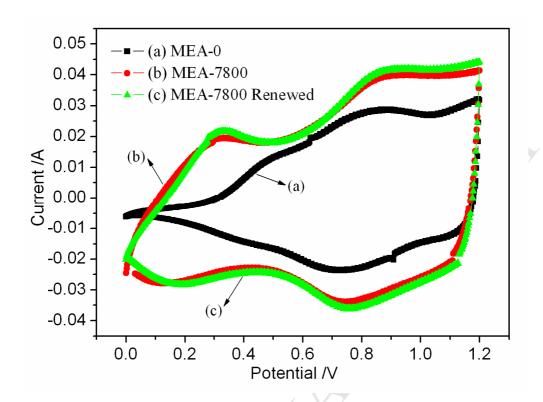
Fig.6

The performance of the anode catalyst was investigated using cyclic voltammograms (CV). We can see from Fig. 6, the CVs of MEA-7800 and MEA-7800 Renewed display the characteristic expansion in comparison with that of MEA-0. The increase in the total integral charge after 7800 h is ascribed to the gradual oxidation of Ir atoms available in the catalyst layer, which leads to hydration of the iridium oxide and increase of the number of active sites accessible for the electrochemical reaction [25]. The peaks are broad and not very well depicted, suggesting an existence of variety of active surface sites with different formal potentials, which is consistent with the amorphous state of the iridium oxide [25]. In addition, a pair of broad peaks for MEA-7800 sit at the potential range of around 0.6 V-1.0 V vs.SHE. Particularly, the anodic peak of MEA-7800 localizes 0.78 V-1.1 V vs.SHE, and the peak is approximately horizontal, which is attributed to the Ir(III)/Ir(I) and Ir(V)/Ir(VI) redox surface transition [26]. An increase of the peaks of Ir(III) /Ir(IV) and Ir(V)/Ir(VI) redox surface transition is observed after 7800 h, which may be attributed to an increase of the number of active surface sites. This also indicates that the contaminants do not cover with active surface sites in the anode catalyst layer and only occupy the ion exchange sites in the catalyst layers. Moreover, the evident Pt peaks are observed at the anode, which may be attributed to the trace amount of porous titanium disc electroplated Pt draining into anode catalyst during the long-term operation.

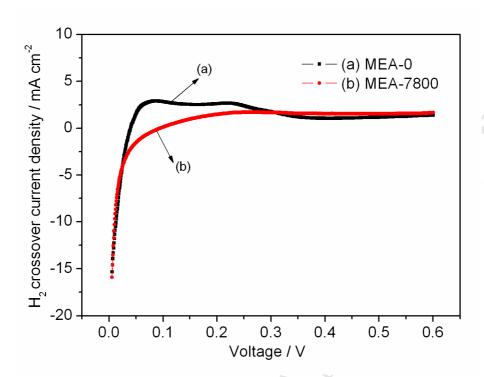
Fig.7

Fig. 7 shows the hydrogen crossover rate of the membrane before and after 7800 h operation. The hydrogen crossover rate can be determined using the plateau current density at voltage above 0.35V, where the current density obtained is limited by the hydrogen transport rate through the membrane [27]. As shown in Fig. 7, the hydrogen crossover current density increases slightly from 1.28 mA cm⁻² (Fig. 7a) to 1.56 mA cm⁻² after 7800h operation (Fig. 7b). Due to the pressure results in the membrane thin during the fabrication process, which would increase the hydrogen crossover rate of the membrane to a certain extent.

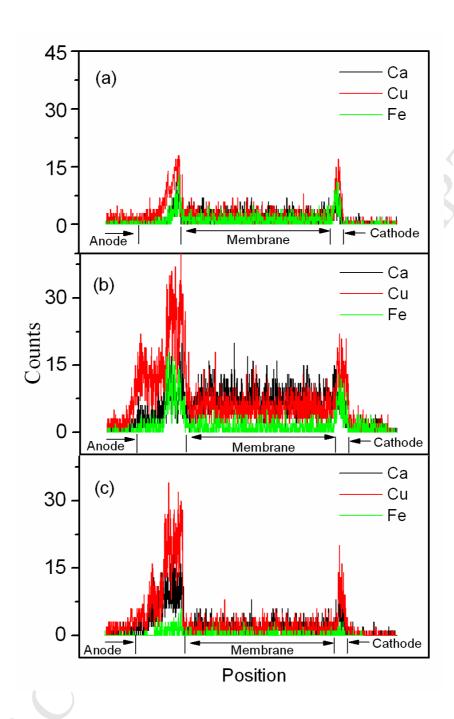
Fig.8

Fig. 8 shows the EPMA (electron probe microanalysis) results at the cross-section of the CCMs (the catalyst-coated membrane) from MEA-0, MEA-7800 and MEA-7800 Renewed. The distributions of Ca, Cu and Fe were analyzed. Compare to Fig. 8 a and Fig. 8c, the elements content in the membrane and anode catalyst layer shows higher relative intensity in Fig. 8 b, whereas it increases slightly in the cathode catalyst layer. This can be attributed to the low content of Nafion polymer electrolyte in the cathode catalyst layers and higher affinity of cations than protons for the sulfonic acid group sites[28-30], which also proves that metallic cations migrates from the anode to the cathode[24]. When the metallic cations gradually accumulate and approximate saturation in MEA, leading to a gradual increase of voltage at constant stack current and holds stably (see in Fig. 2). After recovery, the content of Cu and Ca almost approximates that of MEA-0, whereas Fe element shows lower relative intensity in Fig. 8c, which indicates that the concentration of the elements content obviously decreases in the MEA-7800 Renewed after being recovered with dilute sulfuric acid. The residual cations have little influence on cell performance (see in Fig. 3 - 4).

In addition, Cu and Fe still exist in other forms in the cathode catalyst layer. Cu²⁺ has quite positive Nernst potential and can be easily reduced to Cu at the cathode, which could cover with catalyst and block the active sites of platinum[31]. Moreover, Nernst potentials of Fe³⁺ is -0.01 V vs. SHE, so underpotential deposition (UPD) could happen at the cathode [32]. As a result, the cations impurities can occupy the cathode catalytic sites and hinder the delivery channel of protons of Nafion polymer electrolyte and membrane, which will not only increase ohmic resistance but also lead to the increase in charge transfer resistance, as given in Fig. 5.

In order to maintain the stable performance of water electrolyzer, it is important that

the electrolysis stack and system's pipelines should be made of corrosion-resistant material and high purified feed water should be used. Meanwhile, it is preferable that the water quality is measured online.
