# Inspector's Brief: Demo District (Surveillance Zone A)

Date: October 2026 | Surveillance: Sentinel-2 RGB (10 m/pixel) | Model: ChimneyCensus-OBB v1.0 (Rotated IoU mAP: 0.834) | Officer: Inspector Farida Khan

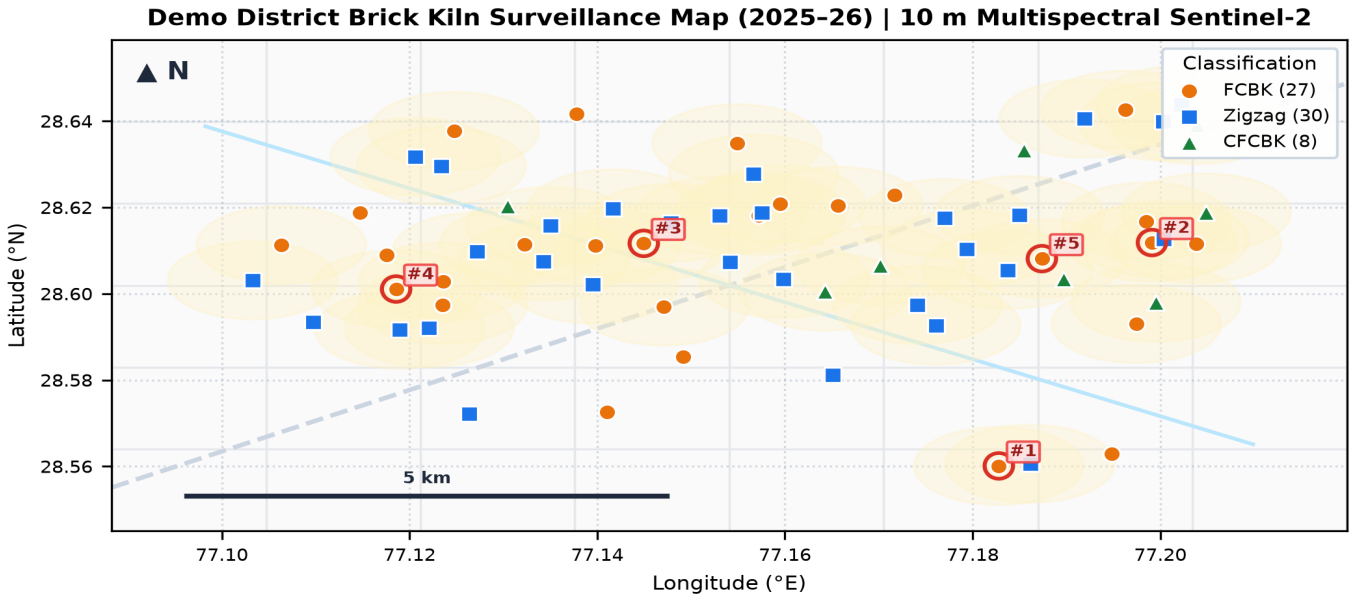
KEY SURVEILLANCE FINDINGS:
- 65 unique active kilns detected across 120 tiles (~154 sq km), deduplicated across 30 px tile overlap boundaries.
- 18 (15–21) baseline 2023–24 FCBKs appear converted to cleaner Zigzag designs (mandate-compliant).
- 27 persistent illegal FCBKs remain in operation post the 2022 ban; 8 circular kilns (CFCBK) require heritage review.
- 51 kilns are clustered within 1 km across 18 local groups, allowing Farida to inspect multiple sites per vehicle patrol.
