BASETech IP camera analysis

Posted on **2020-11-04**

This post in depth describes my analysis of the BASETech (GE-131 BT-1837836) IP camera and the vulnerabilities resulting from this research. This is a rather long blog post, if you are only interested in the vulnerabilities you can skip right to them by skipping to that chapter.

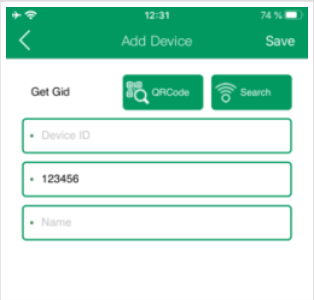
Notably the blue text “the privacy terms” is not a link, it just does nothing, there are no privacy terms you could read. After accepting that you have still read them, you can add a device to the app.

To connect the app needs the device ID and a password. The password field is helpfully already pre-filled with “123456” which is the default password. After connecting to the device the stream is displayed in a small section of the app.

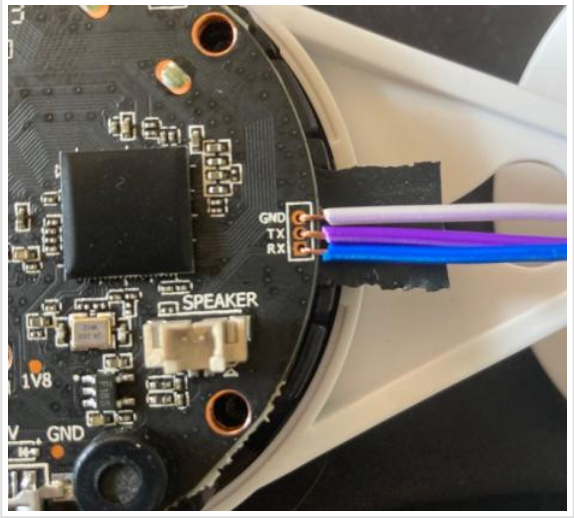
Opening up the hardware device, we can identify connectors on the right hand side of the device that are very likely UART as they are even labeled correctly.

Simply connecting wires to these connectors should be enough, no soldering required!

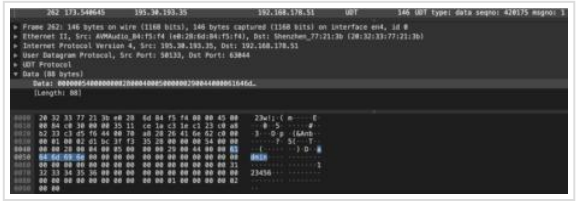
That host responds back with the external IP address of the camera network. If a mobile application connects to the camera, after the initial discovery through the Chinese system, the communication is directly peer to peer. The video stream is never transmitted to the system in China. Most of the communication is done through UDP (and more specifically UDT). The user credentials are sent in plain-text and can be captured trivially on any network device between the systems, in this case username "`admin`" and password "`123456`":

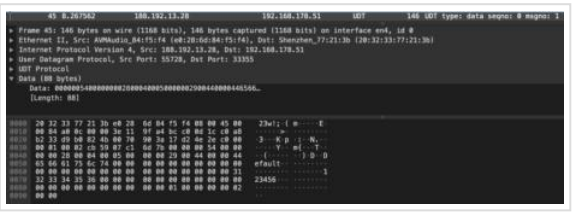
For creating that video the “admin” user password has been changed beforehand, so that any login with that account would fail. Capturing the traffic arriving at the camera also shows that the “Default” user has been sent correctly:

This is extremely critical. Even if a user changed the password of the camera, an attacker can now access the video stream. This again works even if the camera is behind a firewall or NAT device, as long as it has outbound internet connectivity. The “Default” user is not documented, the password of it cannot be changed through the application.

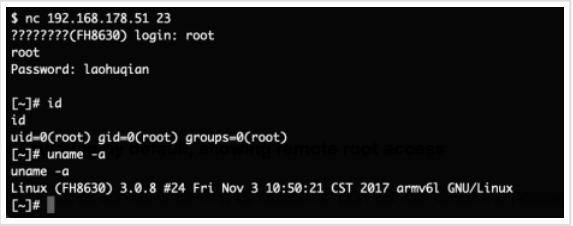
Telnet service running by default, allowing remote root access through hardcoded password (CVE-2020-27555)

On the camera the telnet service is running by default on port 23/tcp. Since the password of the root user is the same across all devices, this allows an attacker with direct network access to simply login as root.

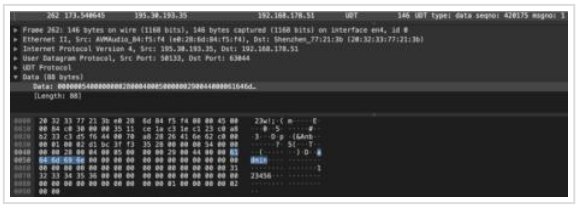
Credentials are sent in plain-text over the network (CVE-2020-27554)

When the mobile application connects to the camera to view a video stream, the username and password is sent plain-text over the network to authenticate.
