Tenda AC9 Wireless Router /goform/WanParameterSetting mask Stack Overflow

1 Basic Information

- Vulnerability Type: Buffer overflow
- Vulnerability Description: A buffer overflow vulnerability exists in the Tenda AC9
 wireless router, firmware version V15.03.05.19. Its /goform/WanParameterSetting
 implementation has a security vulnerability in the processing of mask POST key
 parameters, allowing remote attackers to use the vulnerability to submit special
 requests, resulting in buffer overflow, which can seriously lead to the execution of
 arbitrary OS commands.
- Device model:
 - Tenda AC9 Wireless Router
 - Firmware Version: V15.03.05.19

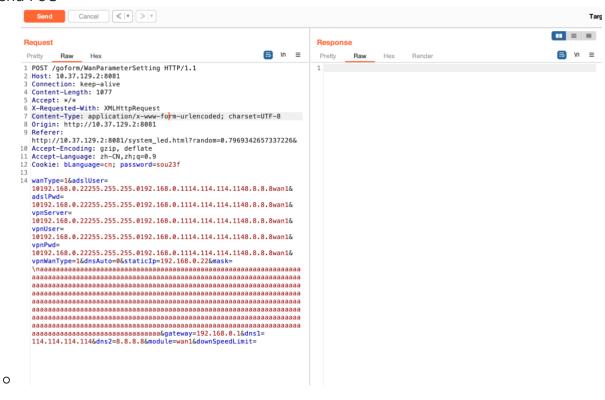
Send PoC

After

This site can't be reached
