Tenda AC9 has bufferoverflow

Tenda AC9 firmware V15.03.2.13 httpd server has stack buffer overflow in form_fast_setting_wifi_set

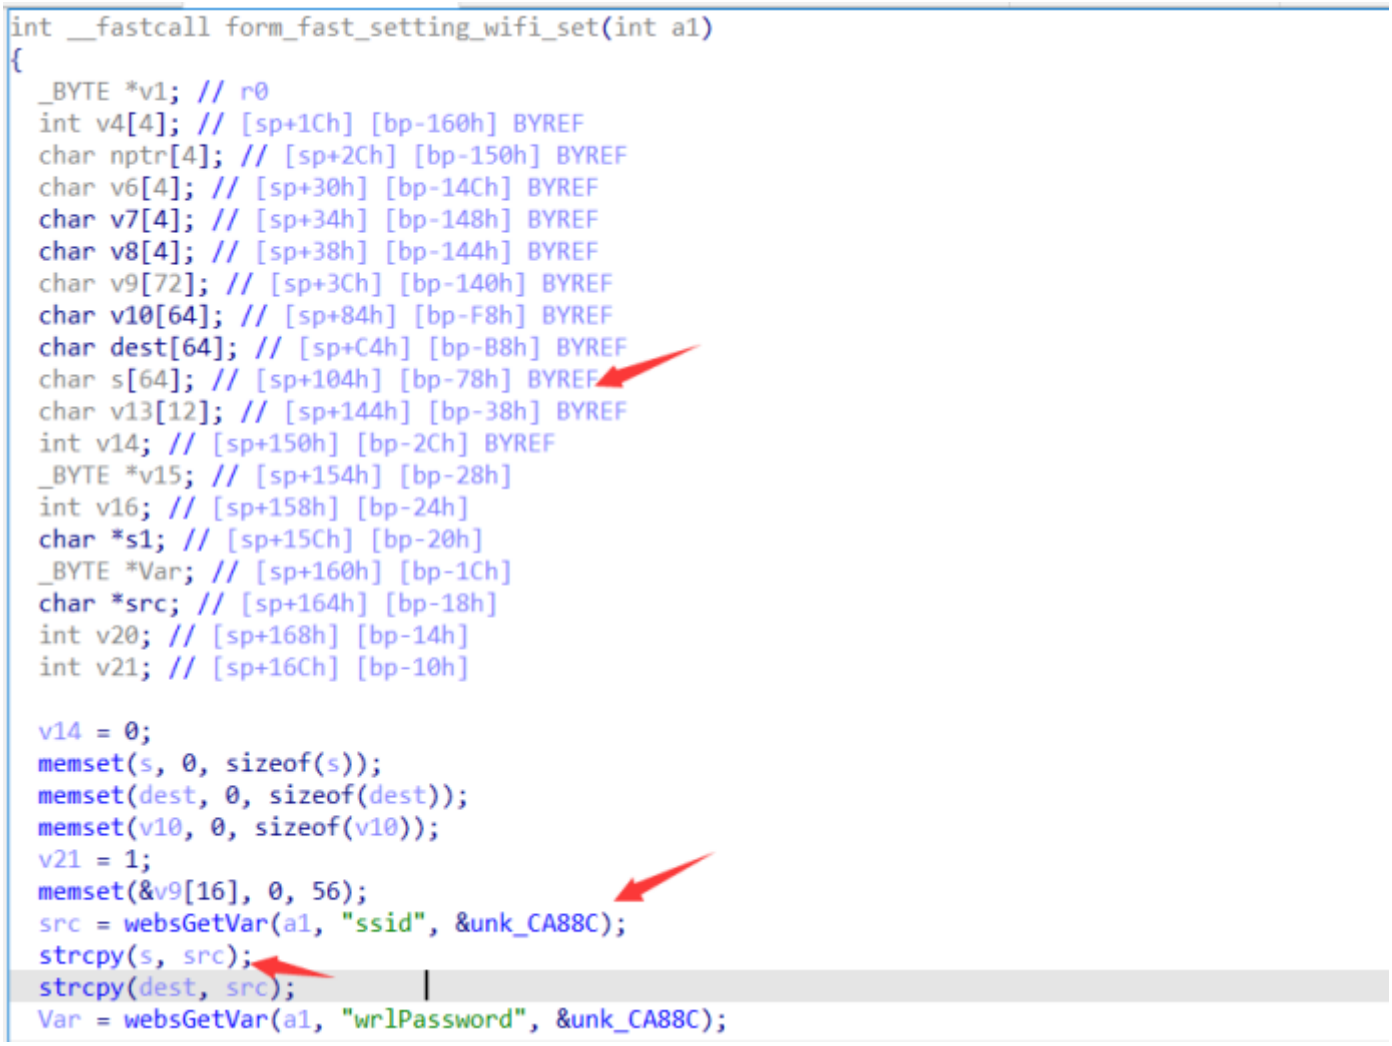
When obtaining the request parameter ssid, no length judgment is performed, and the value of ssid is directly assigned to the local variables s and dest, resulting in a stack overflow vulnerability.

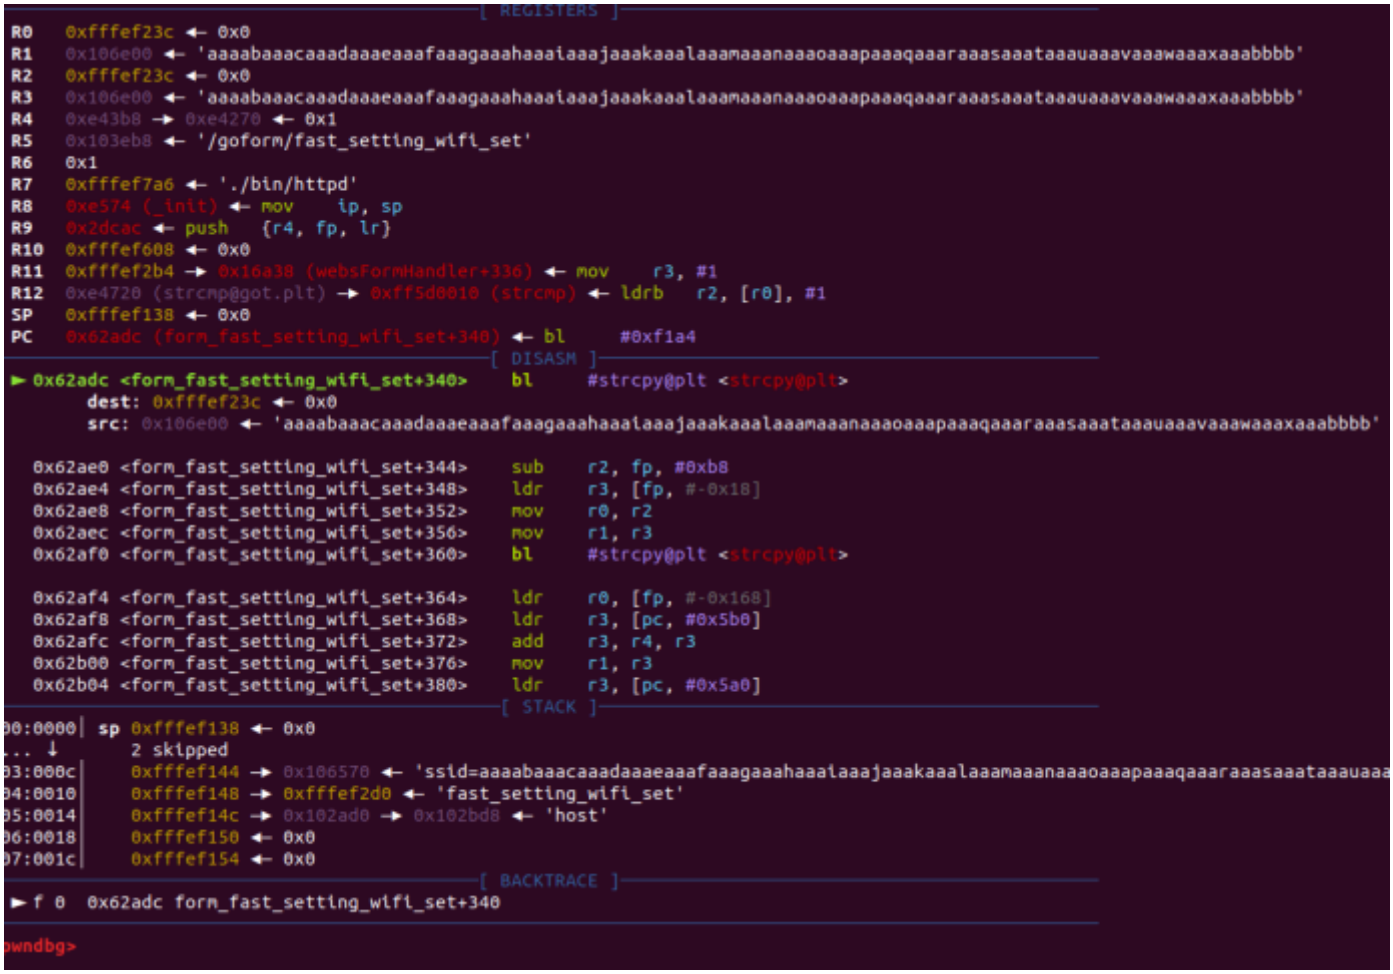
Run the script and use dynamic debugging to check the memory situation, you can see that after the program executes the strcpy function, the value of the r1 register will be tampered with 0x62626262, which is 'bbbb', because of the stack overflow vulnerability, that is to say, as long as we assign more than 96 to the ssid parameter bytes can cause a

denial of service attack.
