3 Vulnerabilities Found on AvertX IP Cameras

By Asher Davila
July 17, 2020 at 9:00 AM
Category: Malware, Ransomware, Unit 42
Tags: botnet, Cybercrime, DDoS, exploit kit, IoT, vulnerabilities

Executive Summary

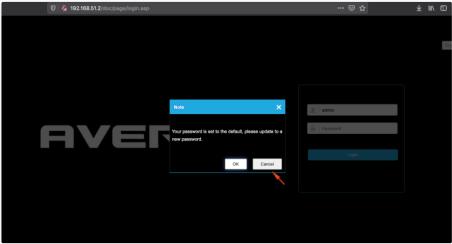
The IP camera does not require users to change the default password for the admin account. Every time the user logs in with the default password, the camera shows a pop-up window suggesting the password be changed, but there's no enforcement. An administrator can click "Cancel" and proceed to use the device without changing the password:

Figure 3. Default password pop-up window that can be ignored

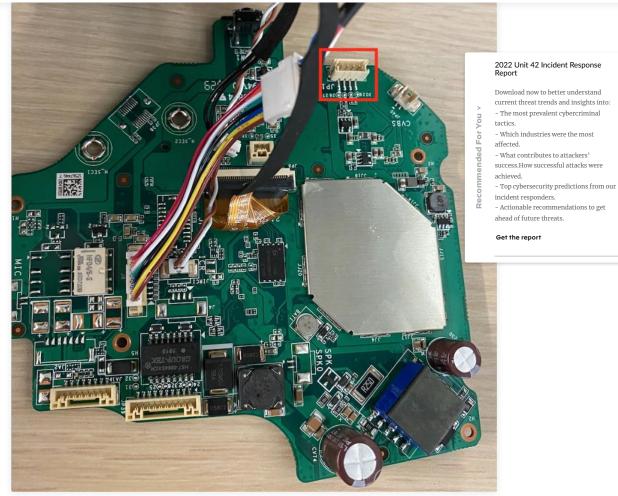
There is an exposed UART interface that allows access to diagnostic and configuration functionalities, and even to system information that can be modified. This security vulnerability can be exploited by attackers with physical access to the UART interface.

The team was able to identify a 4-pin Molex connector that was unpopulated. Most UART interfaces in commercial products are between four and six pins, so the team proceeded to identify and test the pins.

Figure 6. Image of the printed circuit board (PCB), with a 4-pin Molex connector present

AvertX responded quickly when contacted and has released a patch for the issues mentioned above. In addition, AvertX has removed the UART connector and disabled the interface starting with the latest production batch.
