H3C H200[H200-EI] (H200V100R004) has a stack overflow vulnerability

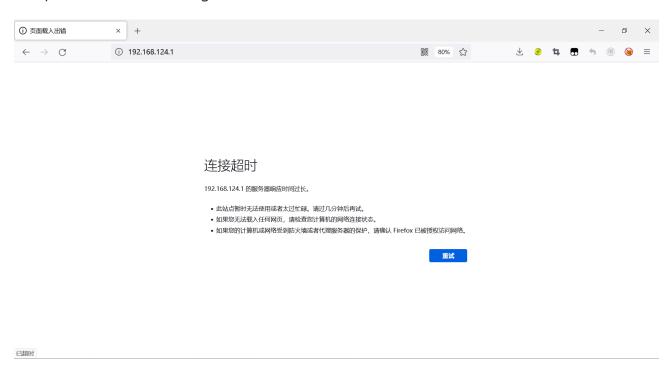
The picture above is the log information.
