DIAS8-02

DTC C 1521 / 21 VGF	RS Actuator Malfunction
---------------------	-------------------------

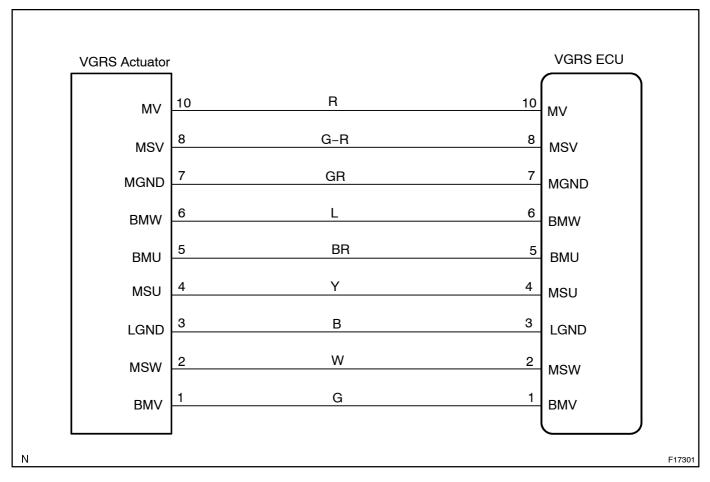
WIRING DIAGRAM

The VGRS ECU drives the actuator while turning the steering wheel to set the gear ratio. It detects the current flowing into the actuator motor driving circuit. When the VGRS ECU detects excessive current, it records the DTC, turns on the VGRS warning light, and stops VGRS operation.

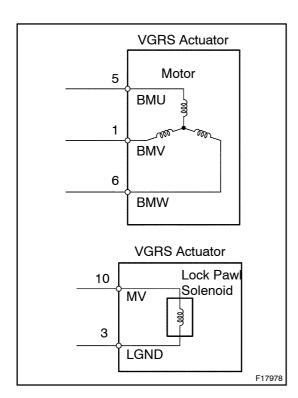
1 Inspect the VGRS actuator.

- (a) Turn the ignition switch OFF.
- (b) Disconnect the actuator connector from the VGRS ECU. **CHECK:**
- (a) Measure resistance between terminals.

Symbols (Terminals)	Resistance
BMV (1) - BMU (5)	
BMV (1) - BMW (6)	0.1 Ω to 1. Ω
BMU (5) - BMW (6)	
MV (10) - LGND (3)	1 Ω to 100 Ω

(b) Check continuity between terminals of actuator connector and body ground.

Symbols (Terminals)	Specified condition
BMV (1) – Body ground	
BMU (5) – Body ground	
BMW (6) – Body ground	No Continuity,
MV (10) – Body ground	
LGND (3) – Body ground

Replace VGRS actuator.

Replace VGRS ECU.
