INSPECTION REPORT

Subject: Request for Installation of Perimeter Fence
Location: Rear of Barangay Hall, Brgy. Topland**,** City of Korondal
Observations:

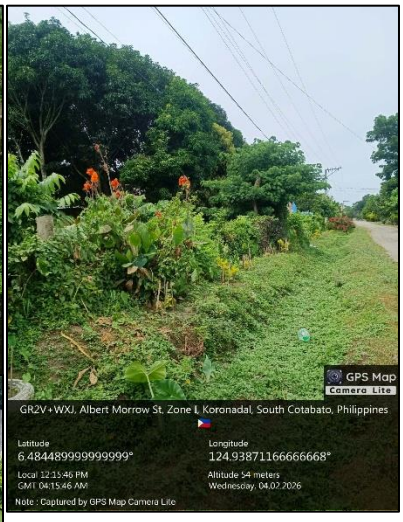
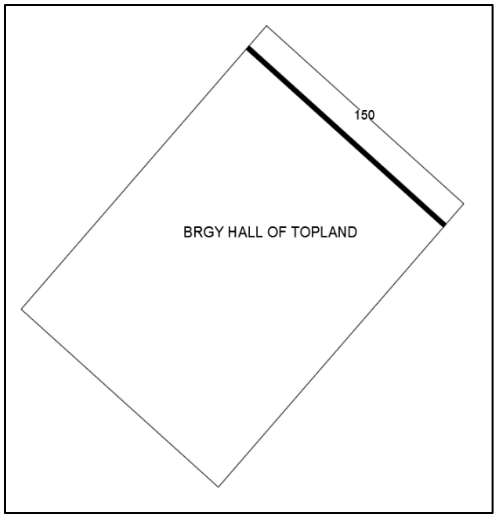
Documentation:

- The only current barriers are dilapidated cyclone wire and temporary bamboo fencing.
- These existing materials are insufficient, deteriorating, and do not provide adequate security for the property.
- The back portion remains largely open and unprotected, marked mostly by overgrown grass and vegetation.
- The lack of a solid barrier allows easy unauthorized access to the Barangay Hall premises.

- A permanent perimeter fence is needed to replace the temporary materials and secure government assets.
- A stable structure is necessary to ensure the safety of the facility and clearly define property limits.

- Construction of a permanent Concrete Hollow Block (CHB) perimeter fence to replace the existing cyclone wire and bamboo.
