INSPECTION REPORT

NAME OF REQUESTER	LOCATION	DESCRIPTION OF REQUESTED MATERIAL	QUANTITY REQUESTED	NAME AND DATE OF INSPECTION
Residents	Prk. Quezon, Brgy. Rotonda	Concrete Pipe (No. 36)	6 Pieces	SEVERINO JOHNROME USERO JANUARY 19,2026
		Cement	6 Bags	
		Sand	1 Load	
		Gravel	1 Load

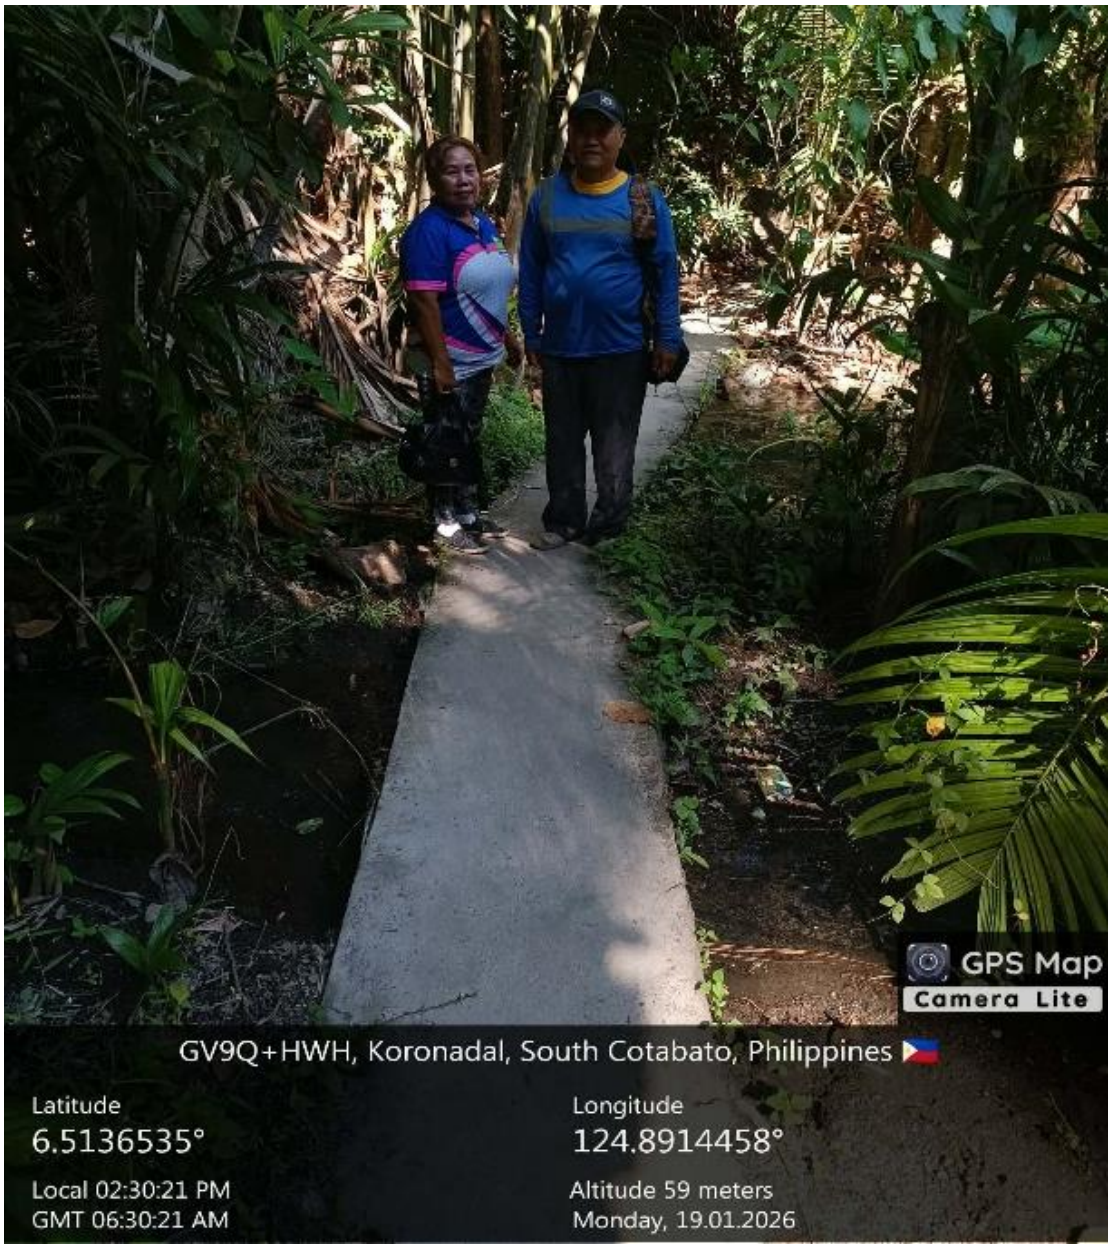
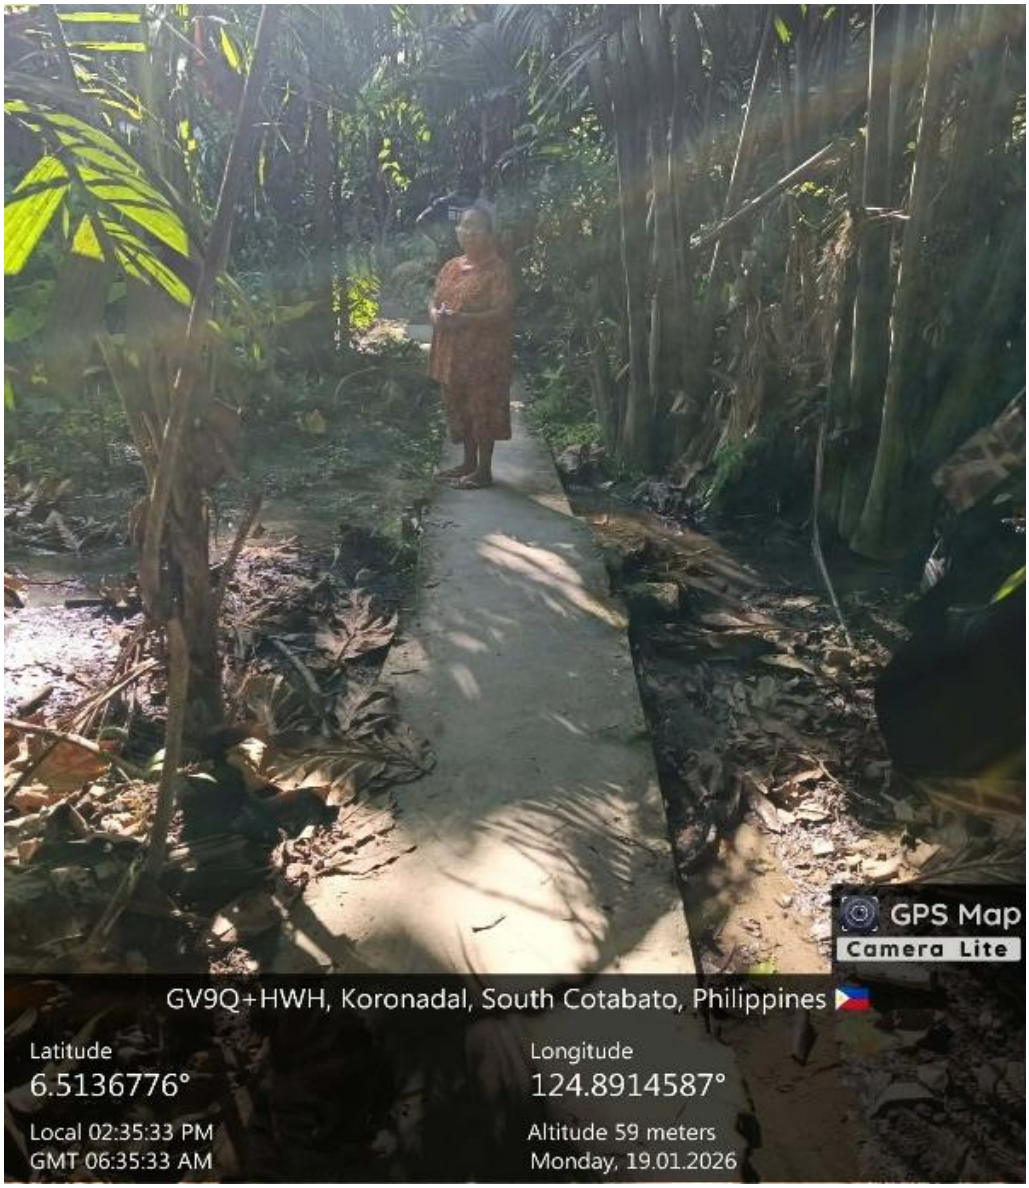
The requested materials are needed to ensure safety and convenience. The area is already wet during the dry season, and conditions are expected to worsen during the rainy season, making passage unsafe. Upon inspection, the originally requested pipe culvert was found to be oversized. An **18-inch pipe culvert** is sufficient and is recommended, as agreed by the area resident representative.
