INSPECTION REPORT

Damaged Concrete Pipe Culvert (Ø 24”)

Location: Brgy. Avancena, Koronadal City
Date Inspected: January 19, 2026

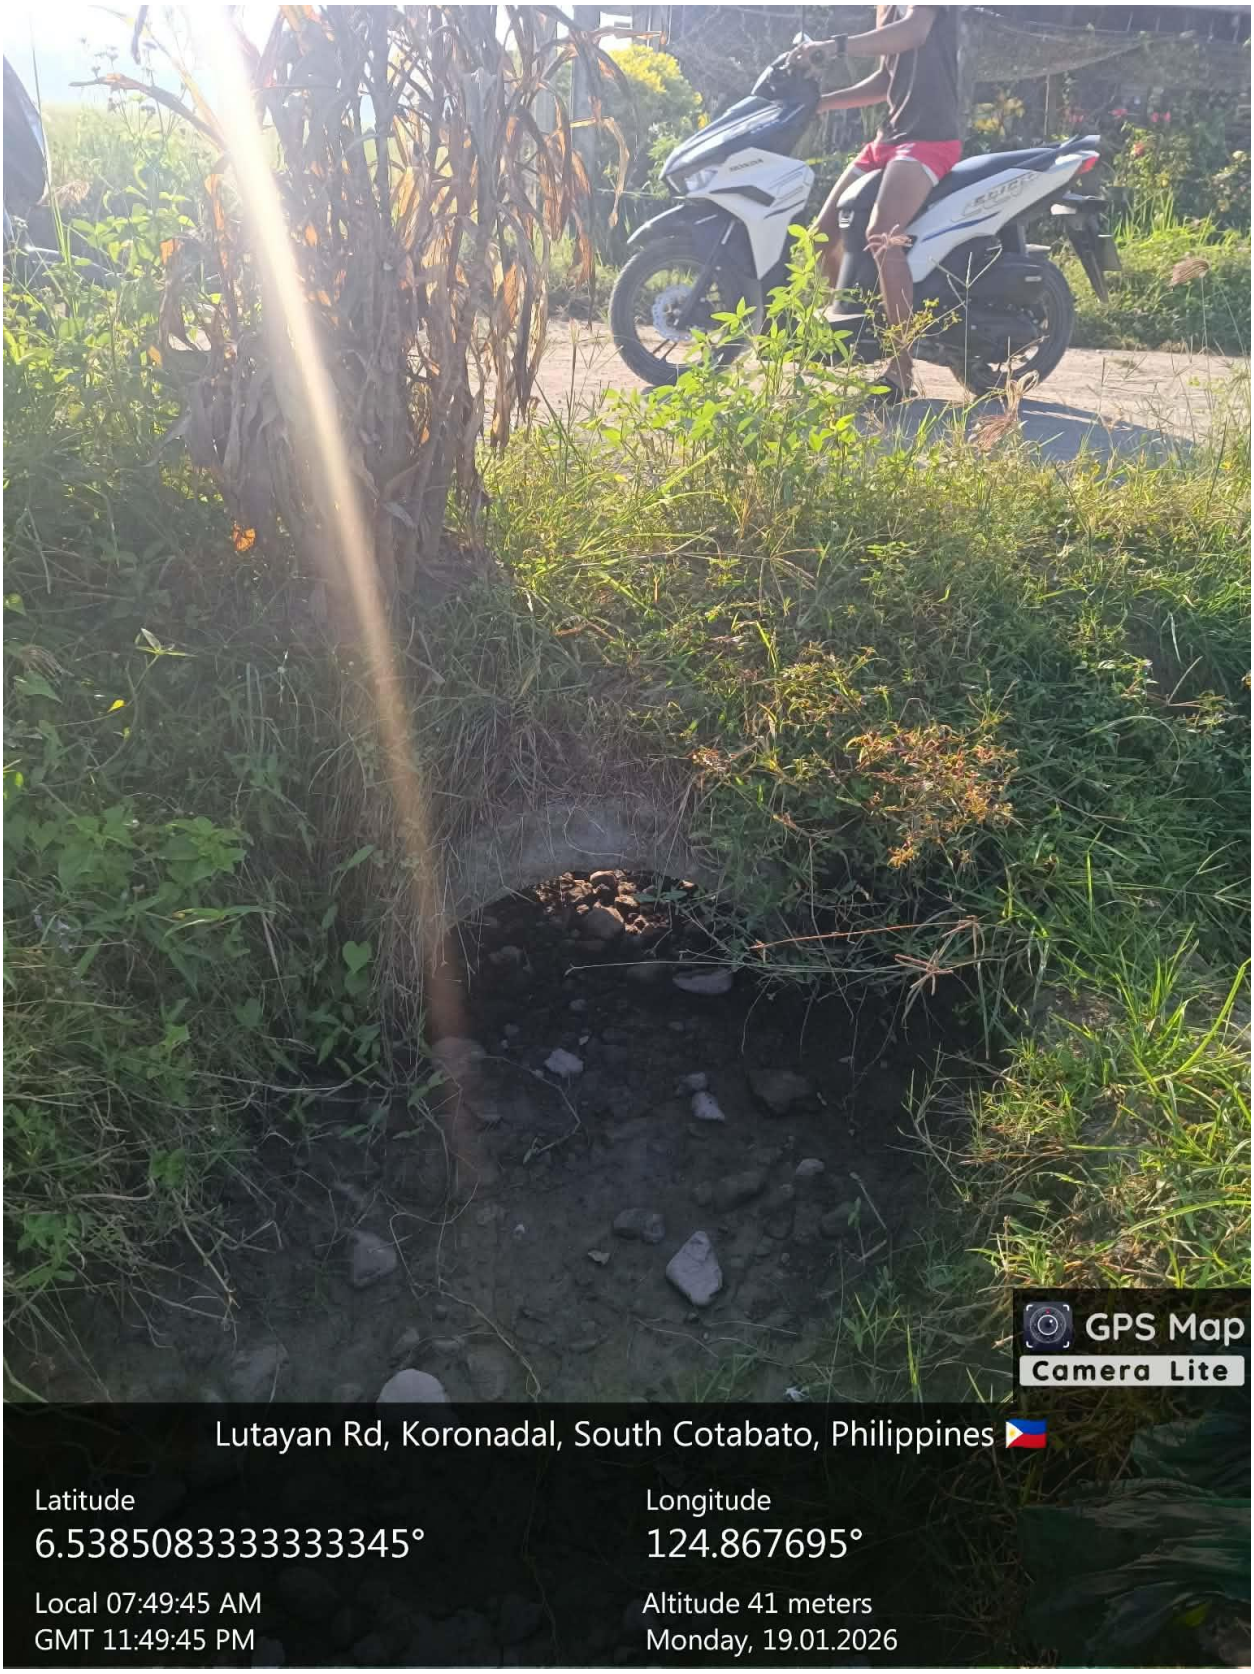
Findings:
The existing 24-inch concrete pipe culvert is damaged and partially collapsed, causing open holes and uneven road surface. The condition is dangerous for drivers and may cause vehicular accidents.

Recommendation:
Immediate replacement of the damaged culvert is recommended to prevent accidents and further road deterioration.
