INSPECTION REPORT

Repair of Public Market Comfort Rooms at the old perimeter building along Alunan Avenue

Location: Public Market, Koronadal City
Inspected by: Engr. Severino Johnrome E. Usero
Date Inspected: January 20, 2026

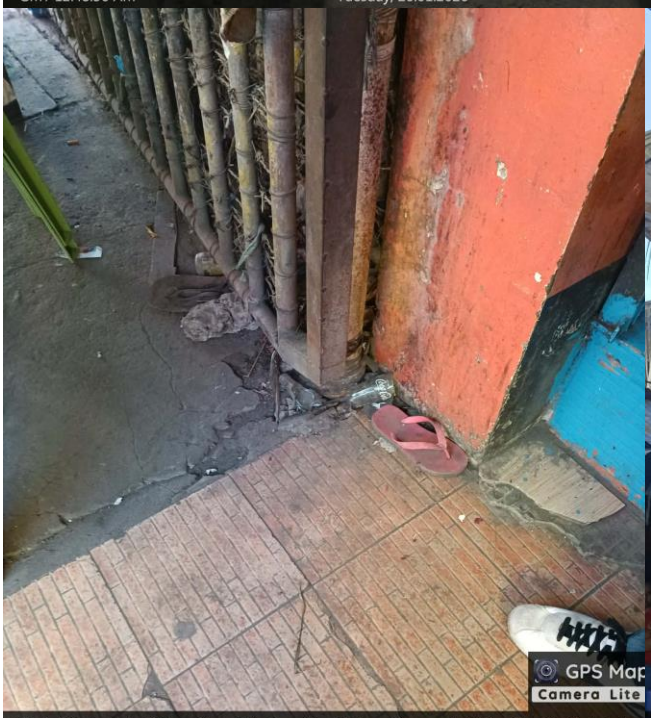
1. Sanitary Pipes
    - Existing sanitary pipes from the 2nd floor comfort rooms are damaged, cracked and leaking.
    - Pipes are exposed, improperly supported and use inappropriate fittings, causing frequent leakage.
    - Presence of strong foul odor along pipe routes indicated active leakage and poor venting
2. Pipe Layout and fittings
    - Vertical drop use sharp elbows without clean-outs
    - Inadequate venting system contributes to odor accumulation.
3. Septic Tank
    - Existing septic tank (approx. 2.7m x 5.2 meters, depth unknown) is always full
    - Persistent odor remains even after desludging indicating structural failure and insufficient depth.
4. Public Health Risk
    - Continuous odor affects vendors and the general public.

1. Replace all damaged and leaking sanitary pipes from comfort rooms to septic tank.
2. Install proper pipe fittings, clean outs and air vent.
3. Construct new reinforced septic tank.
