INSPECTION REPORT

Building: Tesda Training Center
Location: Brgy. Carpenter Hills, City of Korondal
Concern: Rainwater leakage due to defective gutter
Purpose of Inspection:
To assess the existing gutter at the Tesda Training Center and determine the necessary corrective measures to improve facility.

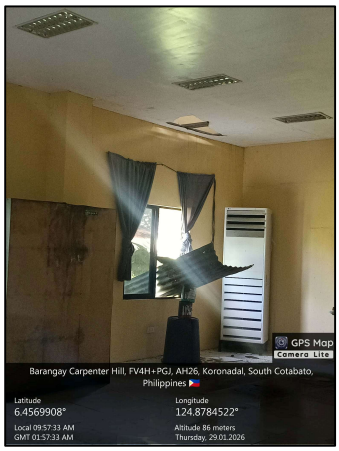
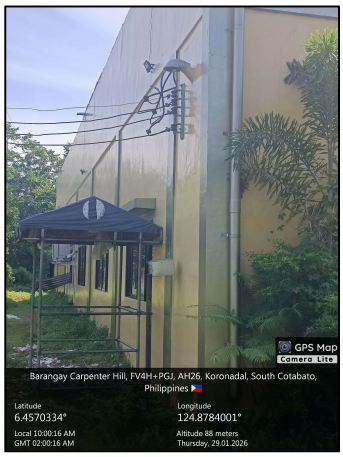
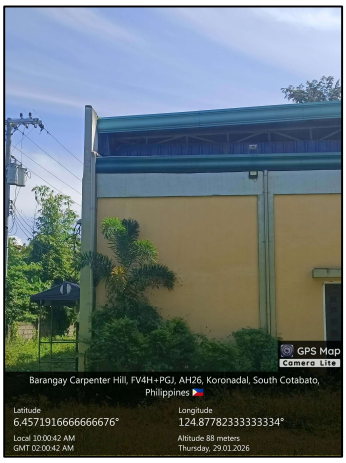
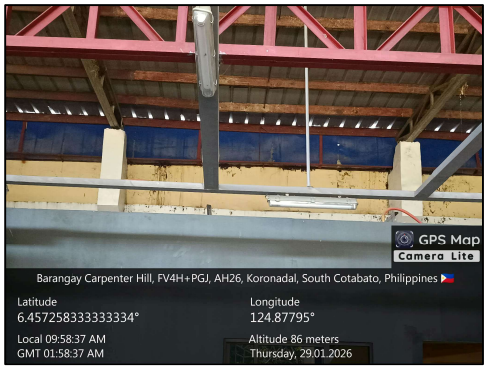
Documentation:

Observation:
The existing interior GI rain gutter is undersized and open, causing stagnant water accumulation. The open gutter allows debris and animal nesting, resulting in blockage and overflow. During rainfall, water enters the building interior, causing damage and partial collapse of the fiber cement board ceiling.

Recommendation:
1. Remove the existing interior gutter system.
2. Extend the roof eaves to allow rainwater to discharge directly outside the building.
3. Install proper roof flashing and drip edge.
4. Ensure rainwater is directed away from walls and building foundation.
5. Replace damaged fiber cement board ceiling and repaint with moisture-resistant paint.
