INSPECTION REPORT

Subject: Request for Installation and Illumination
Building: Governor Sergio B. Morales National High School Gymnasium
Location: Brgy. Paraiso, City of Korondal
Concern: No adequate lighting system in Gymnasium
Findings:
1. Existing lighting fixtures in the building are non-functional.
2. Installed electrical wiring is undersized and not adequate for the required lighting load.

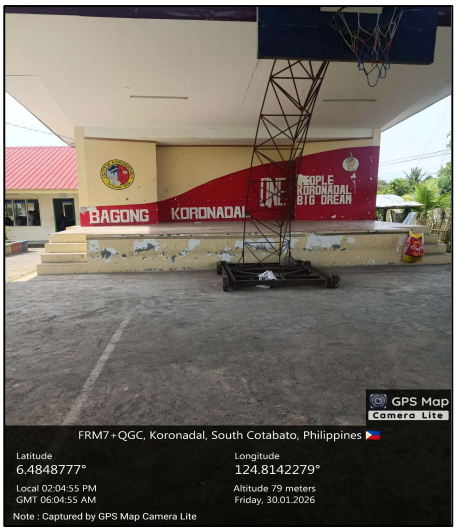
Additional Concern and request during inspection: The stage paint is already deteriorated and requires repainting to improve appearance and usability.
