Date on which inspection and testing was carried out: 27/06/2023

Installation Address: Infratec UK Ltd (UNIT 8), Easter Park, Unit 8, Barton Road, Middlesbrough, TS2 1RY

UNSATISFACTORY

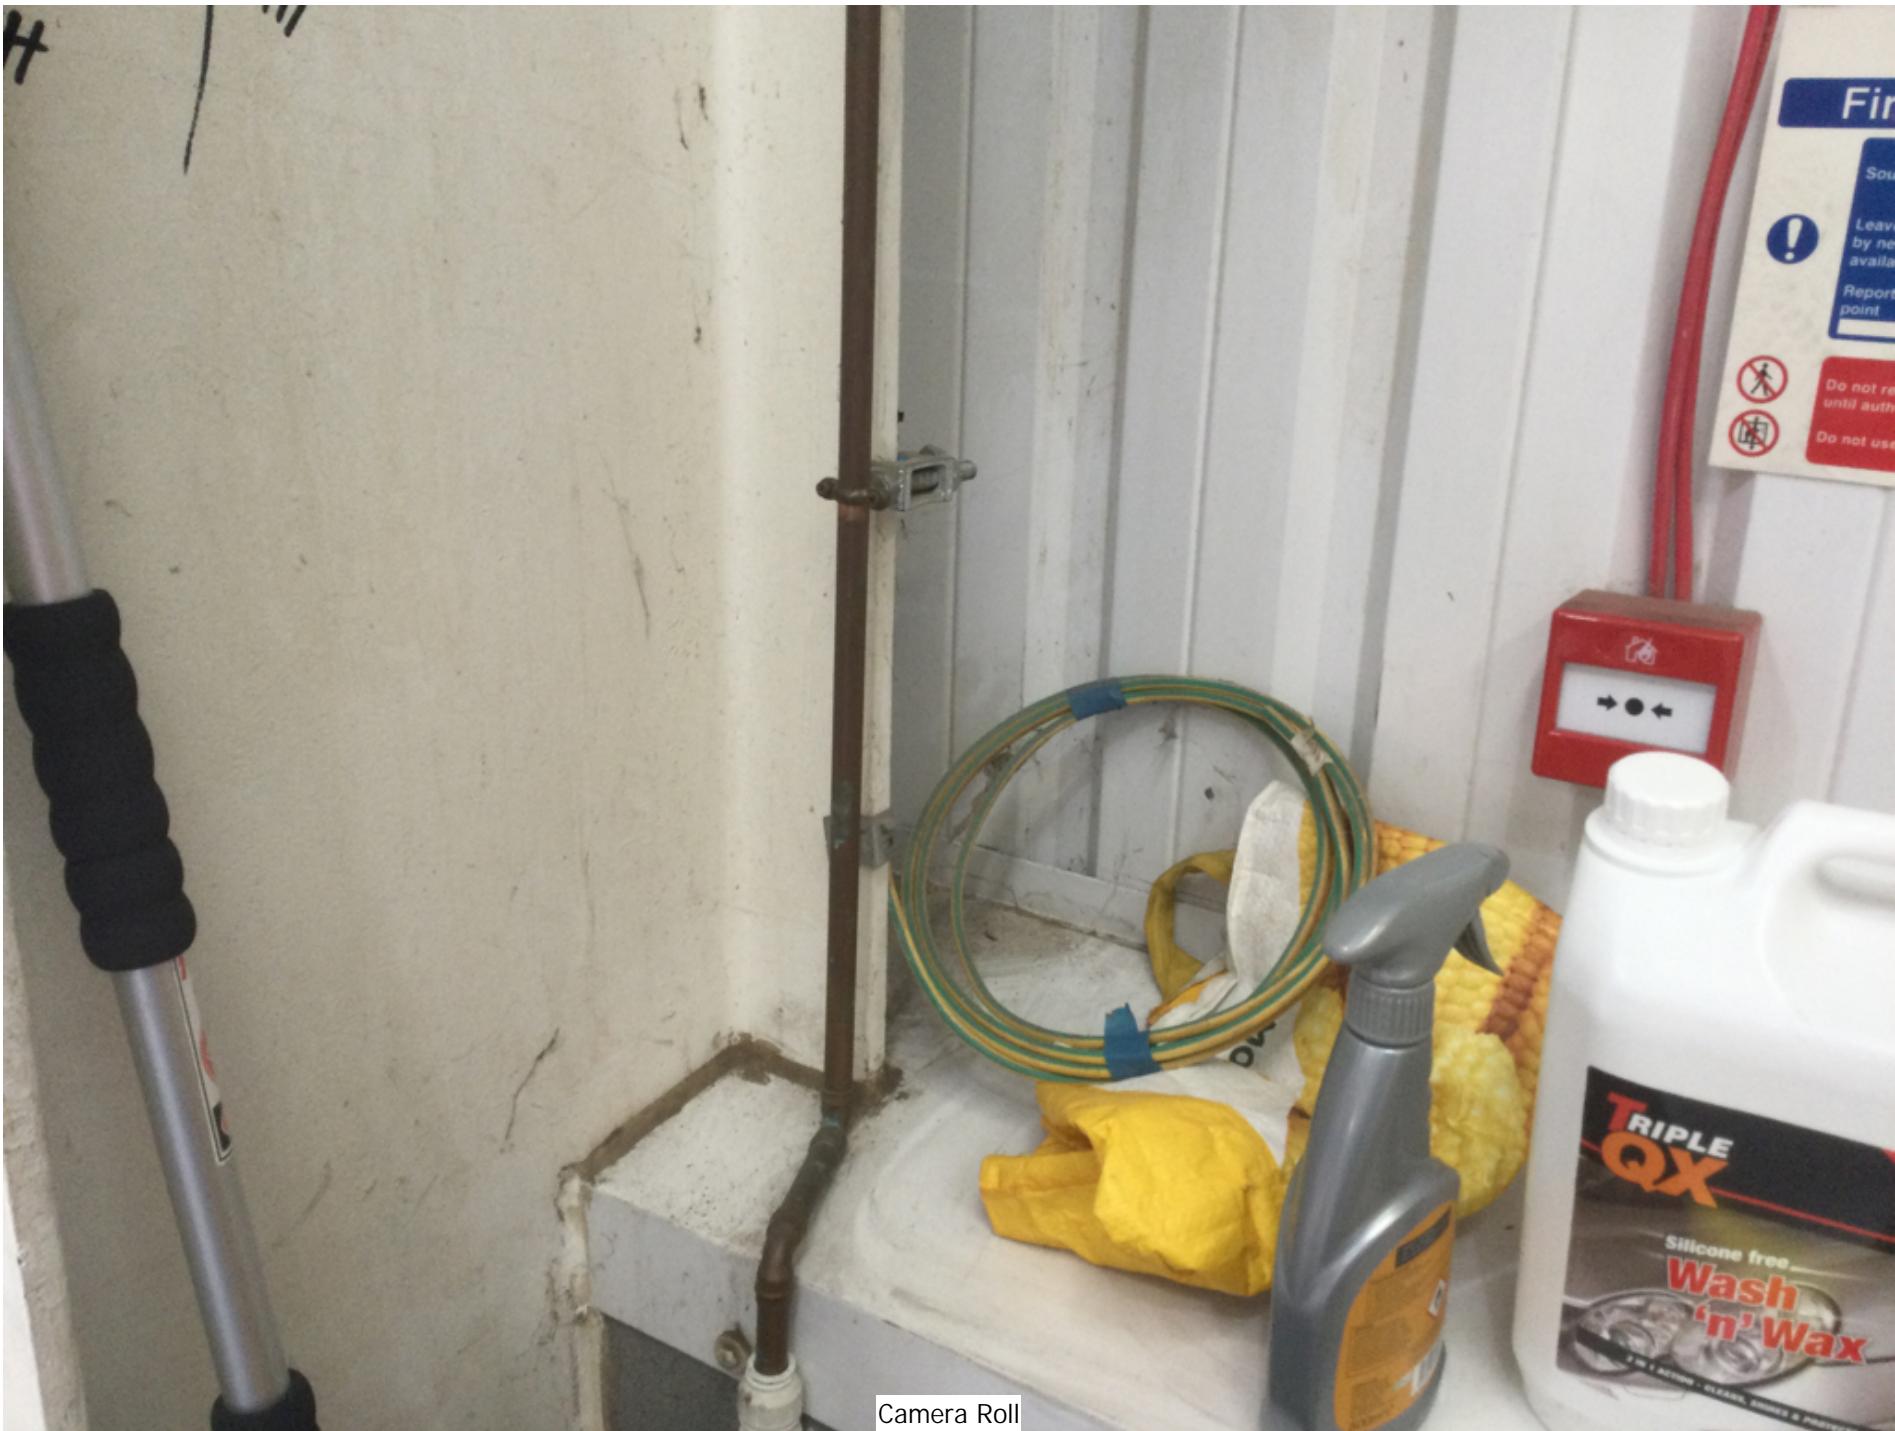
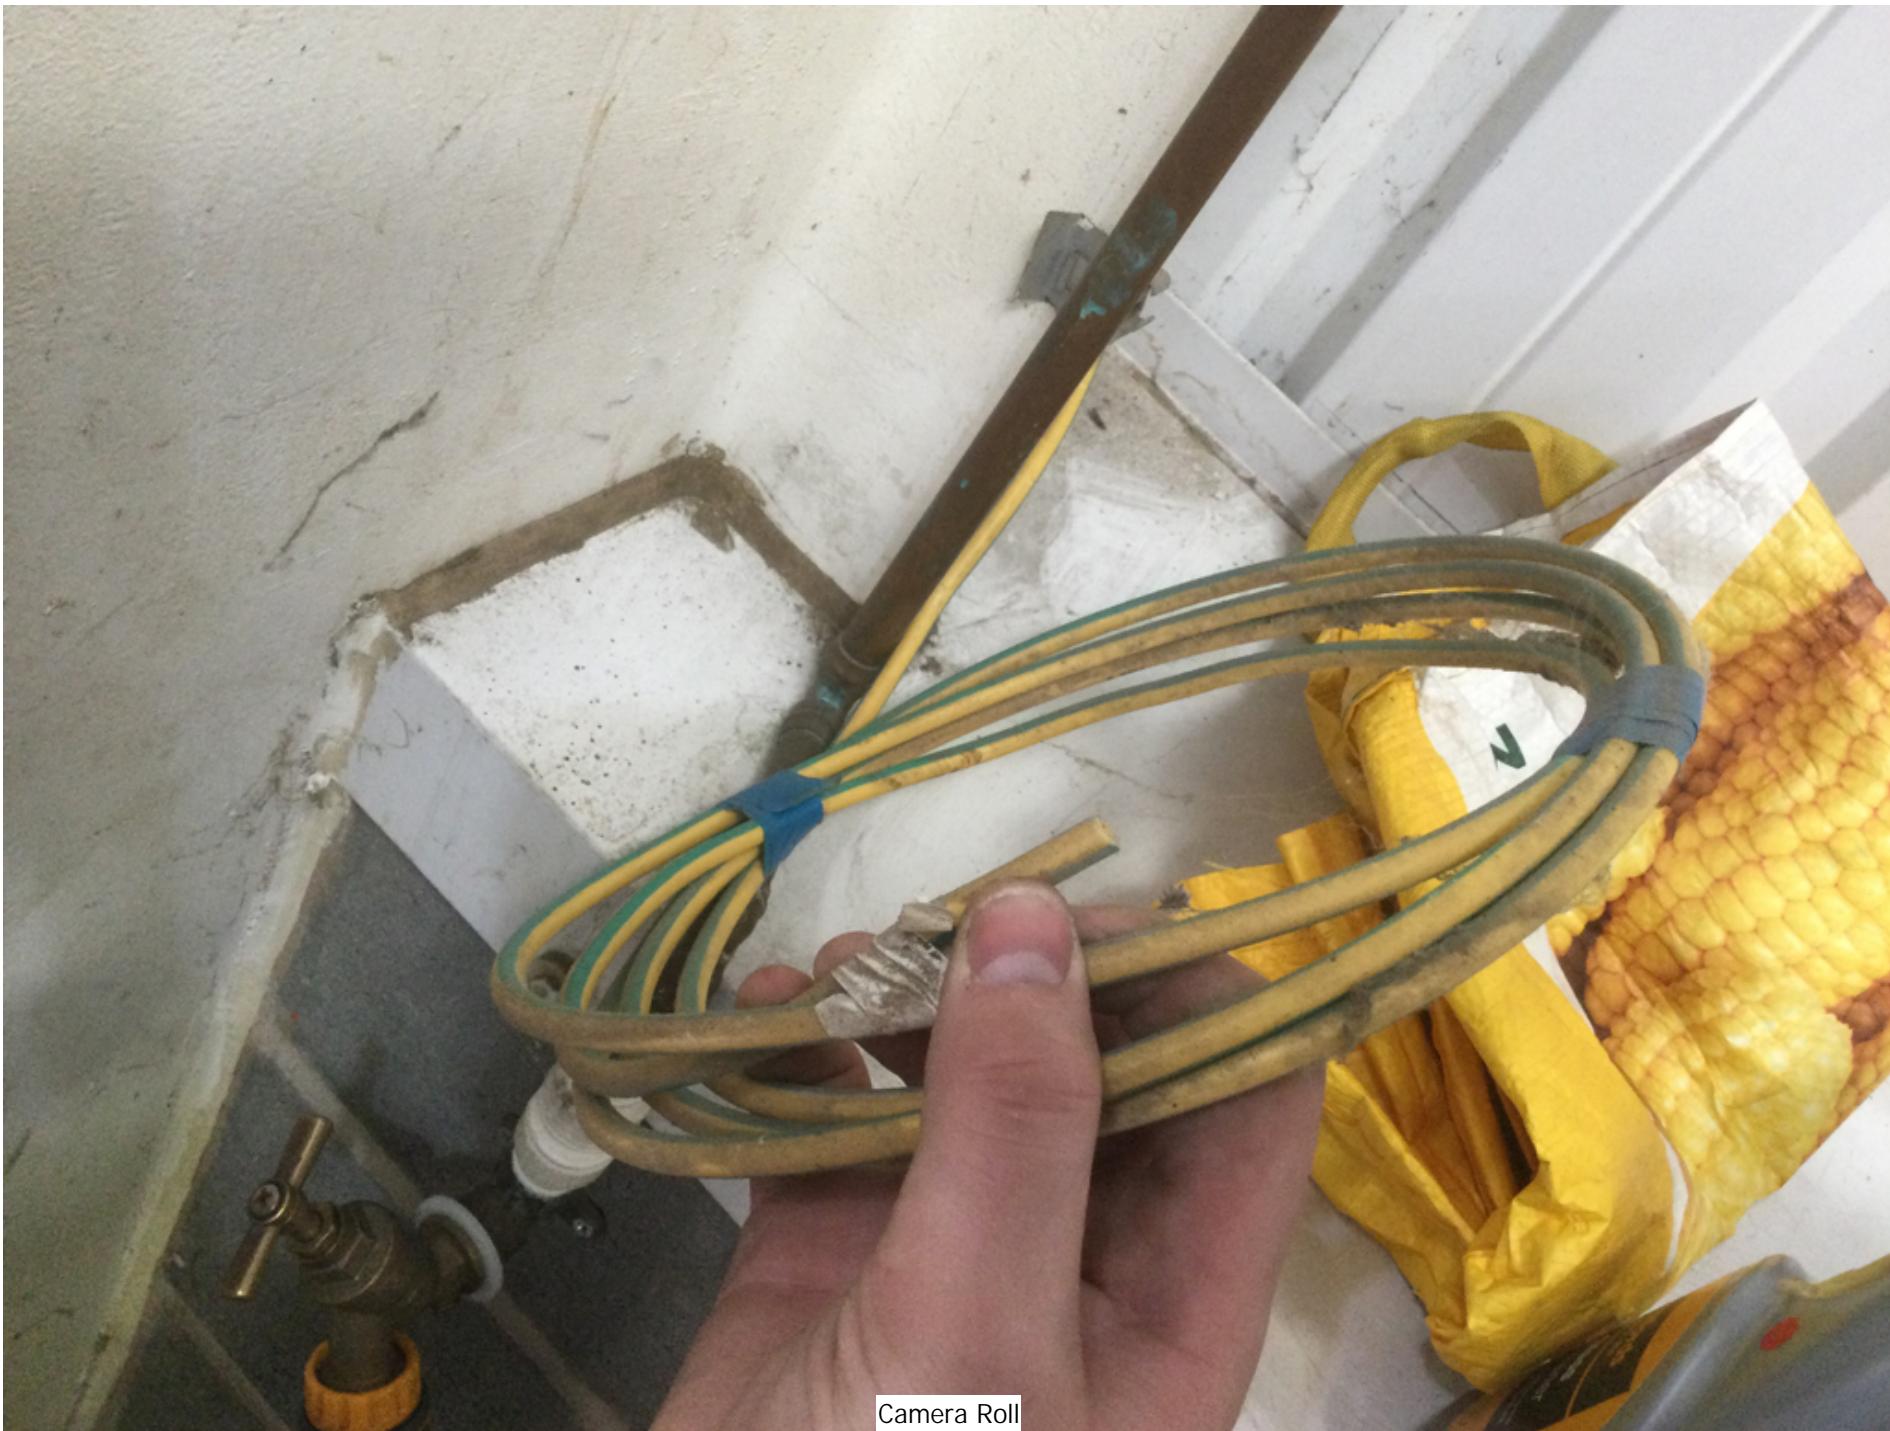
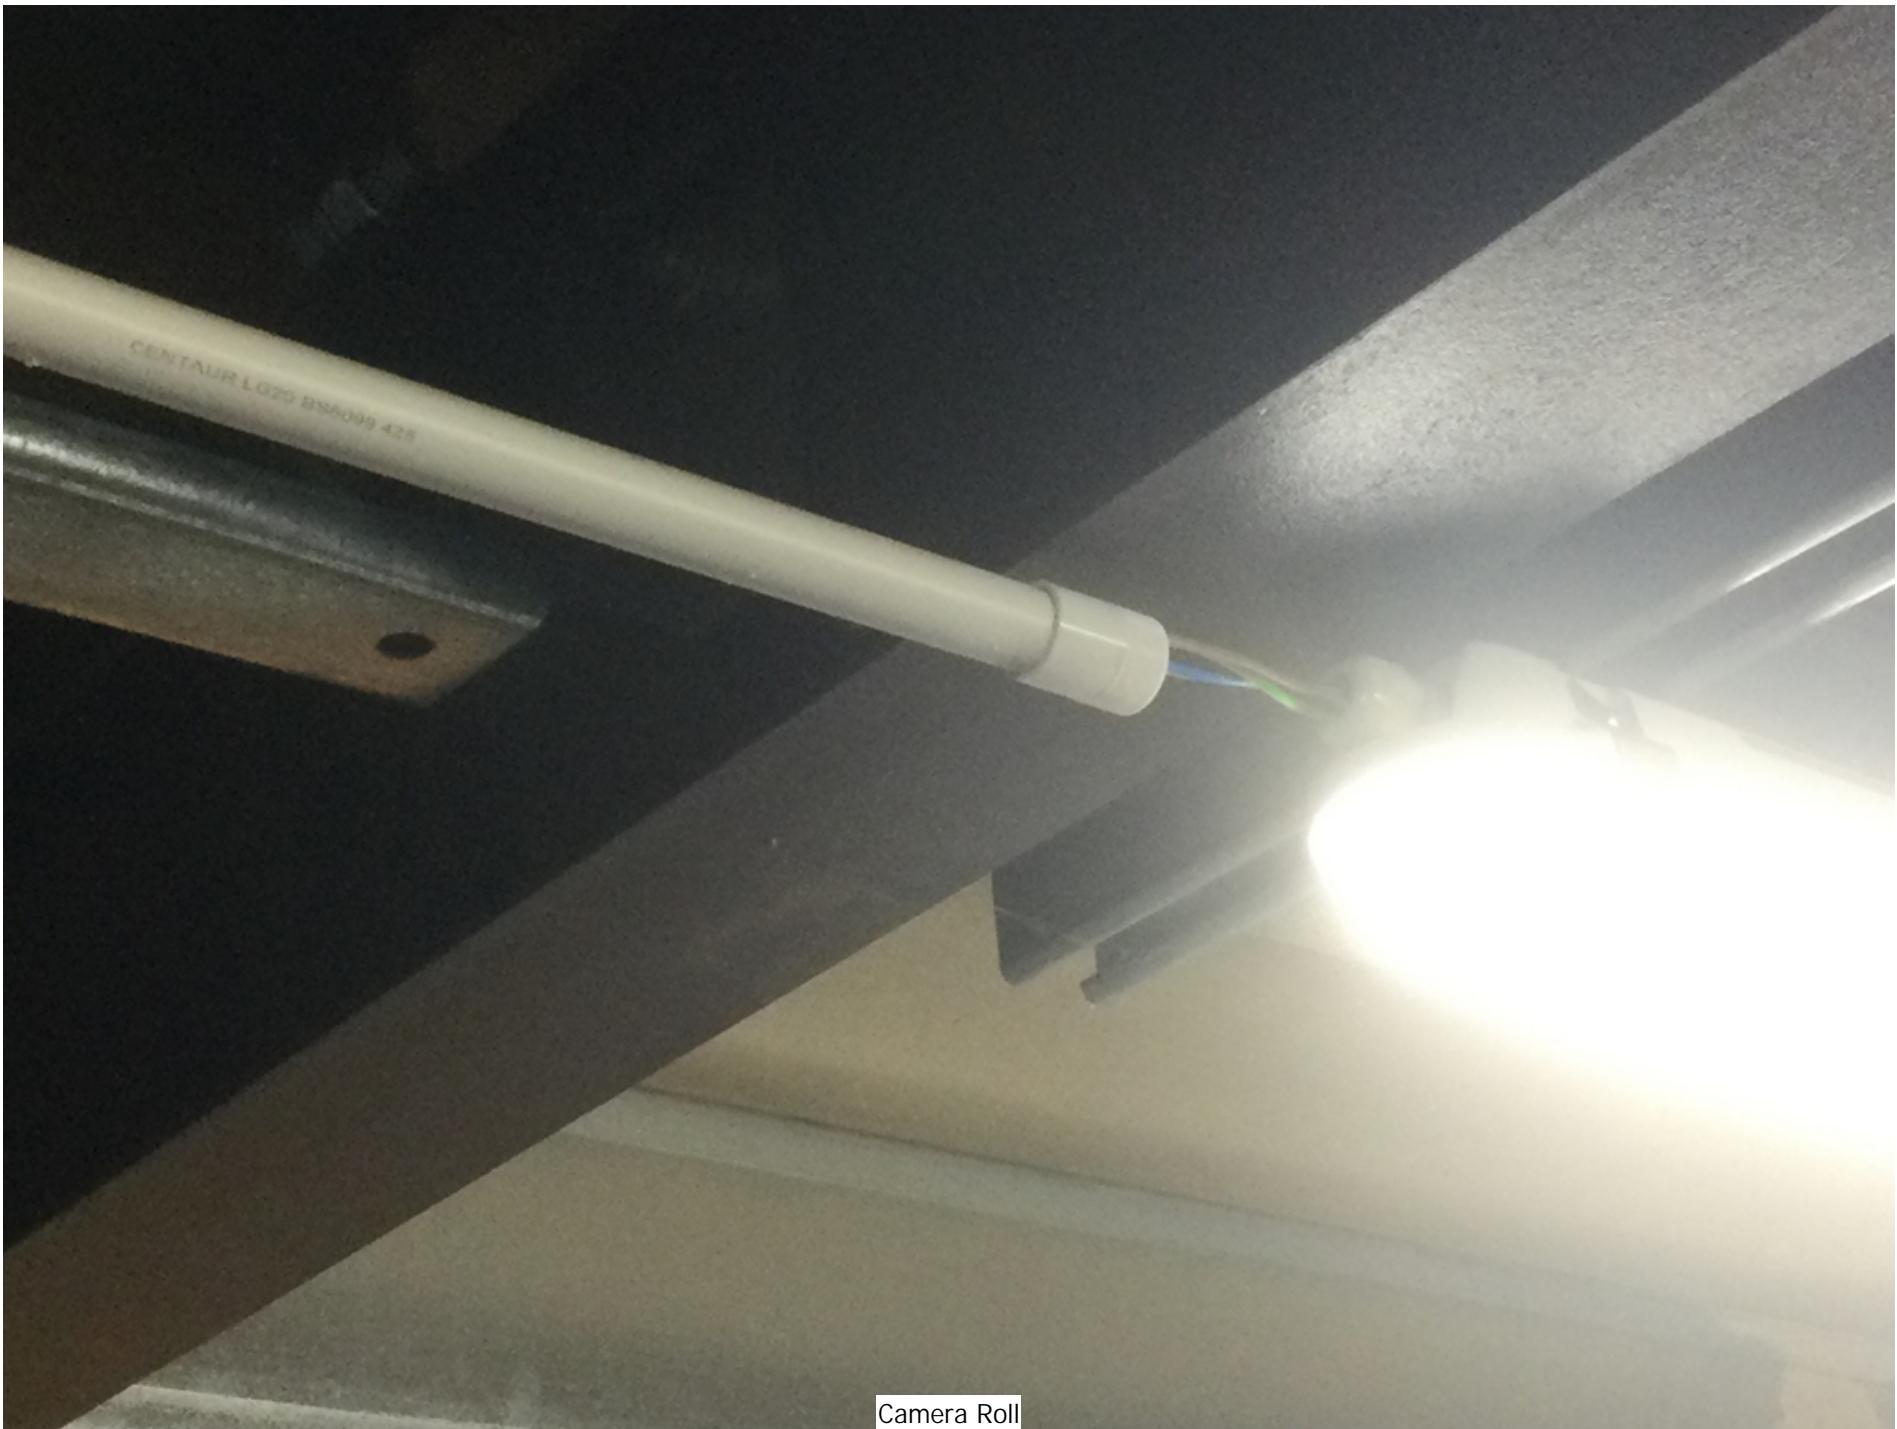
Overall install is quite poor, gas bonds not connected and other faults observed have been listed in observations with a few pictures to illustrate. Work required for satisfactory
