VISUAL INSPECTION SUMMARY REPORT

Optronics S.A. de C.V.

File Name: S26940-192600003A

Serial Number: S26940-192600003

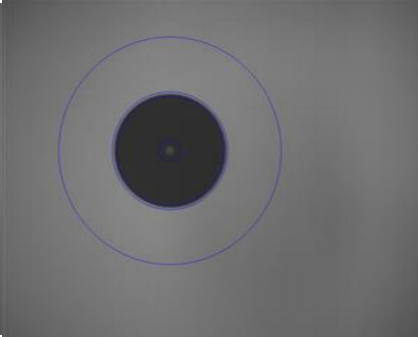
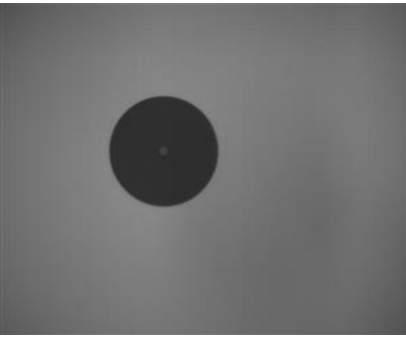
Zone Name	Diameter		Result	Defects		Scratches	
	Inner	Outer		Count	Area (μ2)	Result	Count
Zone A	0	25	PASS	0	0	PASS	0
Zone B	25	120	PASS	0	0	PASS	0
Zone C	120	130	PASS	0	0	PASS	0
Zone D	130	250	PASS	0	0	PASS	0
Zone E	250	1000	PASS	0	0	PASS	0
Epoxy Gap:	PASS	Fiber Type:	Simplex	Core Size:	9		
LOW Magnification				High Magnification

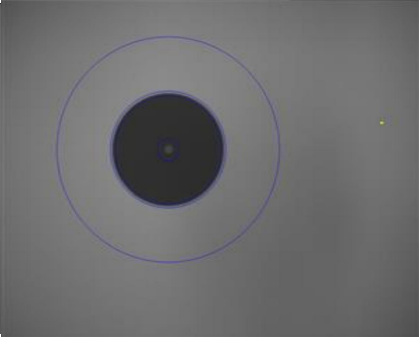
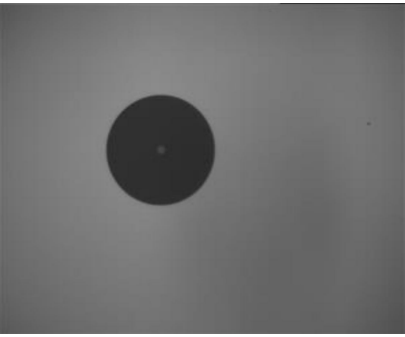
File Name: S26940-192600003B

Zone Name	Diameter		Result	Defects		Scratches	
	Inner	Outer		Count	Area (μ2)	Result	Count
Zone A	0	25	PASS	0	0	PASS	0
Zone B	25	120	PASS	0	0	PASS	0
Zone C	120	130	PASS	0	0	PASS	0
Zone D	130	250	PASS	0	0	PASS	0
Zone E	250	1000	PASS	1	0	PASS	0
Epoxy Gap:	PASS	Fiber Type:	Simplex	Core Size:	9		
LOW Magnification				High Magnification

****PASS****
