VISUAL INSPECTION SUMMARY REPORT

Optronics S.A. de C.V.

File Name: S26940-192600014A

Serial Number: S26940-192600014

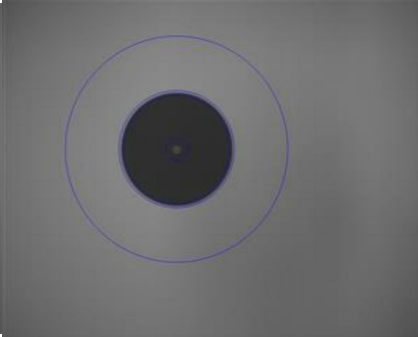
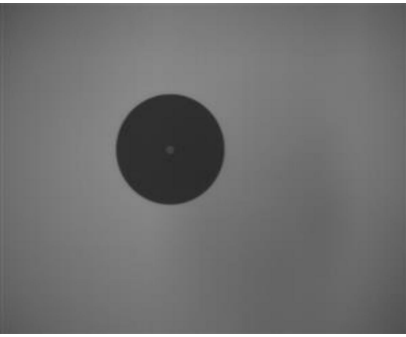
Zone Name	Diameter		Result	Defects		Scratches	
	Inner	Outer		Count	Area (μ2)	Result	Count
Zone A	0	25	PASS	0	0	PASS	0
Zone B	25	120	PASS	0	0	PASS	0
Zone C	120	130	PASS	0	0	PASS	0
Zone D	130	250	PASS	0	0	PASS	0
Zone E	250	1000	PASS	0	0	PASS	0
Epoxy Gap:	PASS	Fiber Type:	Simplex	Core Size:	9		
LOW Magnification				High Magnification

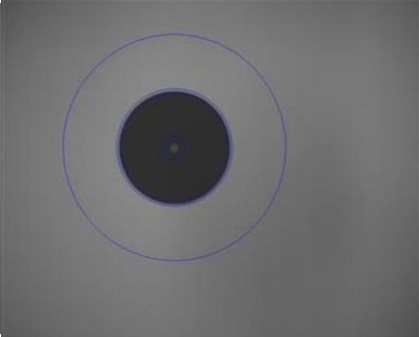
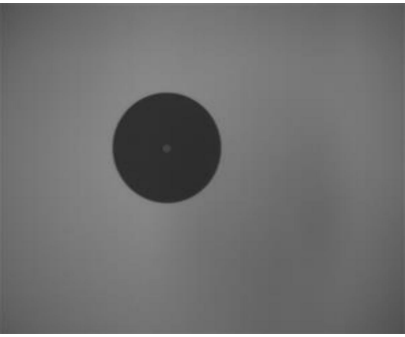
File Name: S26940-192600014B

Zone Name	Diameter		Result	Defects		Scratches	
	Inner	Outer		Count	Area (μ2)	Result	Count
Zone A	0	25	PASS	0	0	PASS	0
Zone B	25	120	PASS	0	0	PASS	0
Zone C	120	130	PASS	0	0	PASS	0
Zone D	130	250	PASS	0	0	PASS	0
Zone E	250	1000	PASS	0	0	PASS	0
Epoxy Gap:	PASS	Fiber Type:	Simplex	Core Size:	9		
LOW Magnification				High Magnification

****PASS****
