VISUAL INSPECTION SUMMARY REPORT

Optronics S.A. de C.V.

File Name: S26940-192600015A

Serial Number: S26940-192600015

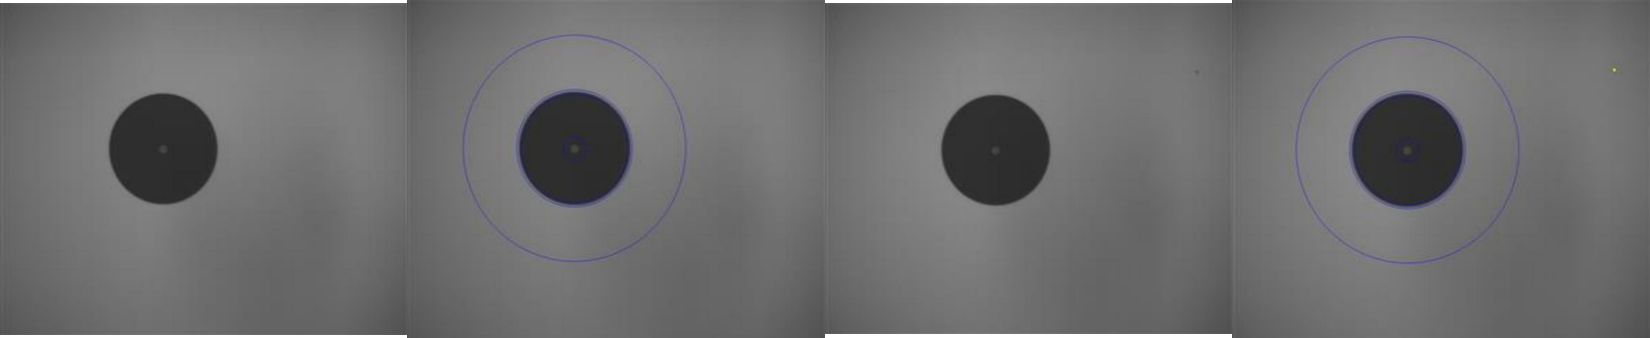
Zone Name	Diameter		Result	Defects		Scratches	
	Inner	Outer		Count	Area (μ2)	Result	Count
Zone A	0	25	PASS	0	0	PASS	0
Zone B	25	120	PASS	0	0	PASS	0
Zone C	120	130	PASS	0	0	PASS	0
Zone D	130	250	PASS	0	0	PASS	0
Zone E	250	1000	PASS	0	0	PASS	0
Epoxy Gap:	PASS	Fiber Type:	Simplex	Core Size:	9		
LOW Magnification				High Magnification
