VISUAL INSPECTION SUMMARY REPORT

Optronics S.A. de C.V.

File Name: S26940-192600001A

Serial Number: S26940-192600001

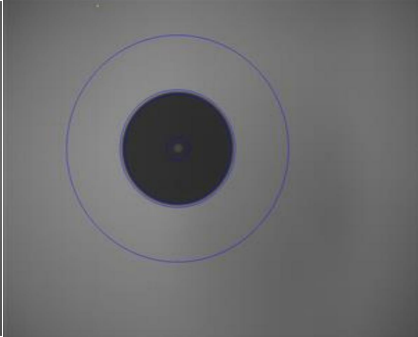
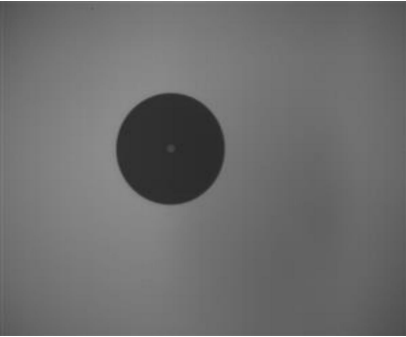
Zone Name	Diameter		Result	Defects		Scratches	
	Inner	Outer		Count	Area (μ2)	Result	Count
Zone A	0	25	PASS	0	0	PASS	0
Zone B	25	120	PASS	0	0	PASS	0
Zone C	120	130	PASS	0	0	PASS	0
Zone D	130	250	PASS	0	0	PASS	0
Zone E	250	1000	PASS	1	0	PASS	0
Epoxy Gap:	PASS	Fiber Type:	Simplex	Core Size:	9		
LOW Magnification				High Magnification

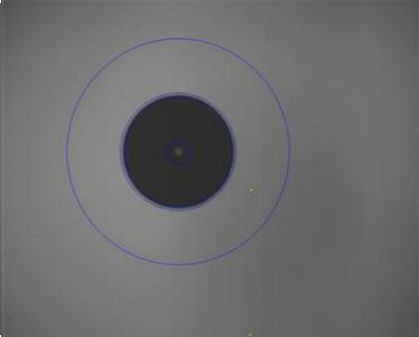
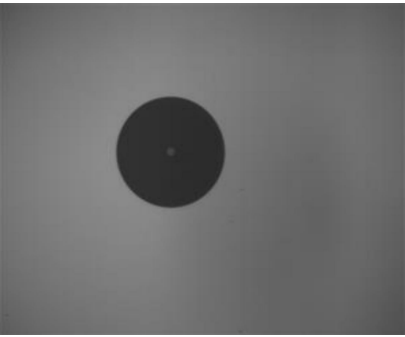
File Name: S26940-192600001B

Zone Name	Diameter		Result	Defects		Scratches	
	Inner	Outer		Count	Area (μ2)	Result	Count
Zone A	0	25	PASS	0	0	PASS	0
Zone B	25	120	PASS	0	0	PASS	0
Zone C	120	130	PASS	0	0	PASS	0
Zone D	130	250	PASS	0	0	PASS	0
Zone E	250	1000	PASS	1	0	PASS	0
Epoxy Gap:	PASS	Fiber Type:	Simplex	Core Size:	9		
LOW Magnification				High Magnification

PASS
