VISUAL INSPECTION SUMMARY REPORT

Optronics S.A. de C.V.

File Name: S26940-192600020A

Serial Number: S26940-192600020

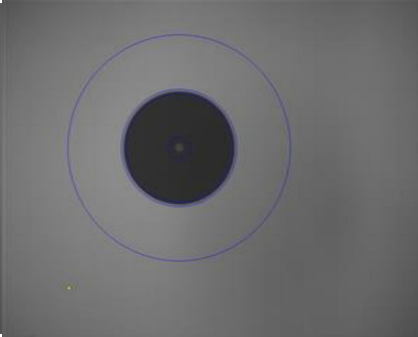
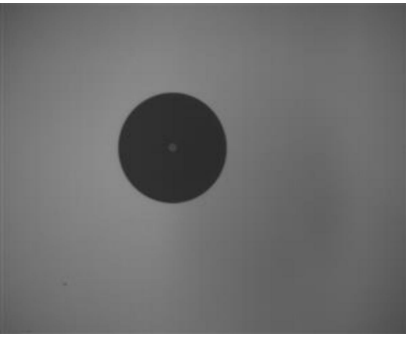
Zone Name	Diameter		Result	Defects		Scratches	
	Inner	Outer		Count	Area (μ2)	Result	Count
Zone A	0	25	PASS	0	0	PASS	0
Zone B	25	120	PASS	0	0	PASS	0
Zone C	120	130	PASS	0	0	PASS	0
Zone D	130	250	PASS	0	0	PASS	0
Zone E	250	1000	PASS	1	0	PASS	0
Epoxy Gap:	PASS	Fiber Type:	Simplex	Core Size:	9		
LOW Magnification				High Magnification

****PASS****

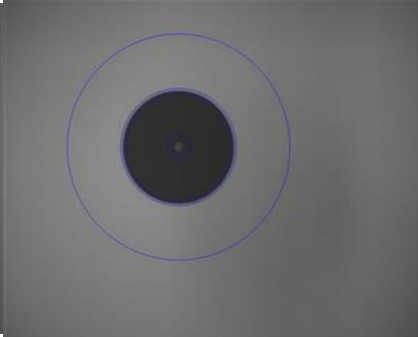
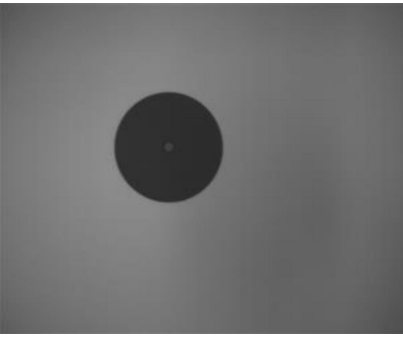
File Name: S26940-192600020B

Zone Name	Diameter		Result	Defects		Scratches	
	Inner	Outer		Count	Area (μ2)	Result	Count
Zone A	0	25	PASS	0	0	PASS	0
Zone B	25	120	PASS	0	0	PASS	0
Zone C	120	130	PASS	0	0	PASS	0
Zone D	130	250	PASS	0	0	PASS	0
Zone E	250	1000	PASS	0	0	PASS	0
Epoxy Gap:	PASS	Fiber Type:	Simplex	Core Size:	9		
LOW Magnification				High Magnification

****PASS****
