VISUAL INSPECTION SUMMARY REPORT

Optronics S.A. de C.V.

File Name: S26940-192600012A

Serial Number: S26940-192600012

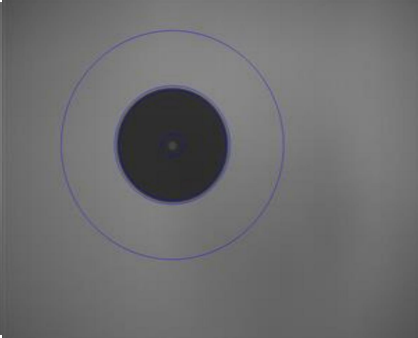
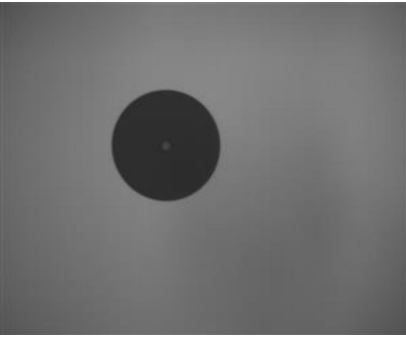
Zone Name	Diameter		Result	Defects		Scratches	
	Inner	Outer		Count	Area (μ2)	Result	Count
Zone A	0	25	PASS	0	0	PASS	0
Zone B	25	120	PASS	0	0	PASS	0
Zone C	120	130	PASS	0	0	PASS	0
Zone D	130	250	PASS	0	0	PASS	0
Zone E	250	1000	PASS	0	0	PASS	0
Epoxy Gap:	PASS	Fiber Type:	Simplex	Core Size:	9		
LOW Magnification				High Magnification

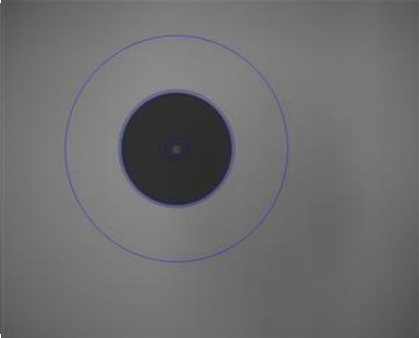
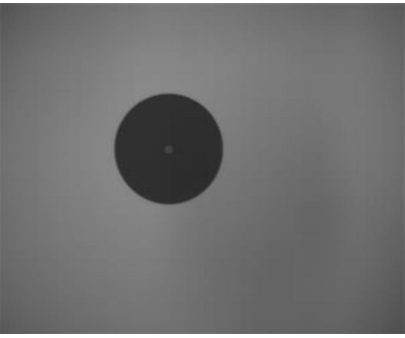
File Name: S26940-192600012B

Zone Name	Diameter		Result	Defects		Scratches	
	Inner	Outer		Count	Area (μ2)	Result	Count
Zone A	0	25	PASS	0	0	PASS	0
Zone B	25	120	PASS	0	0	PASS	0
Zone C	120	130	PASS	0	0	PASS	0
Zone D	130	250	PASS	0	0	PASS	0
Zone E	250	1000	PASS	0	0	PASS	0
Epoxy Gap:	PASS	Fiber Type:	Simplex	Core Size:	9		
LOW Magnification				High Magnification

****PASS****
