VISUAL INSPECTION SUMMARY REPORT

Optronics S.A. de C.V.

File Name: S26940-192600016A

Serial Number: S26940-192600016

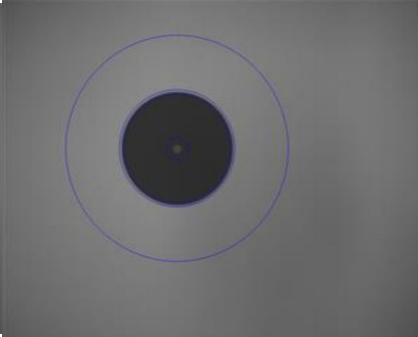
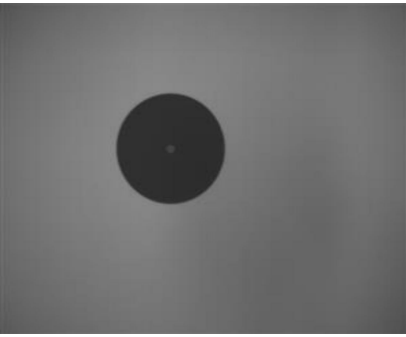
Zone Name	Diameter		Result	Defects		Scratches	
	Inner	Outer		Count	Area (μ2)	Result	Count
Zone A	0	25	PASS	0	0	PASS	0
Zone B	25	120	PASS	0	0	PASS	0
Zone C	120	130	PASS	0	0	PASS	0
Zone D	130	250	PASS	0	0	PASS	0
Zone E	250	1000	PASS	0	0	PASS	0
Epoxy Gap:	PASS	Fiber Type:	Simplex	Core Size:	9		
LOW Magnification				High Magnification

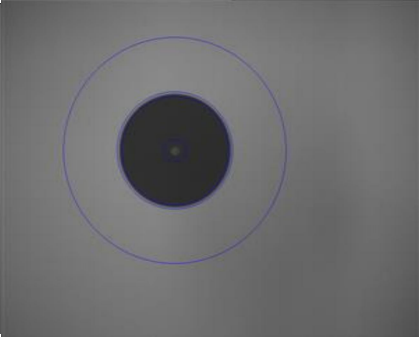
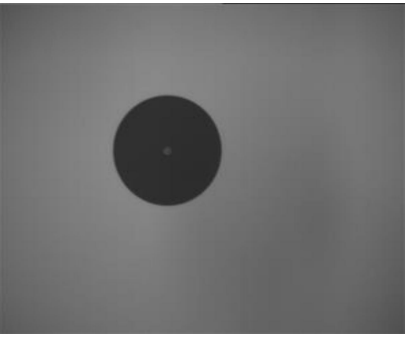
File Name: S26940-192600016B

Zone Name	Diameter		Result	Defects		Scratches	
	Inner	Outer		Count	Area (μ2)	Result	Count
Zone A	0	25	PASS	0	0	PASS	0
Zone B	25	120	PASS	0	0	PASS	0
Zone C	120	130	PASS	0	0	PASS	0
Zone D	130	250	PASS	0	0	PASS	0
Zone E	250	1000	PASS	0	0	PASS	0
Epoxy Gap:	PASS	Fiber Type:	Simplex	Core Size:	9		
LOW Magnification				High Magnification

****PASS****
