VISUAL INSPECTION SUMMARY REPORT

Optronics S.A. de C.V.

File Name: S26940-192600009A

Serial Number: S26940-192600009

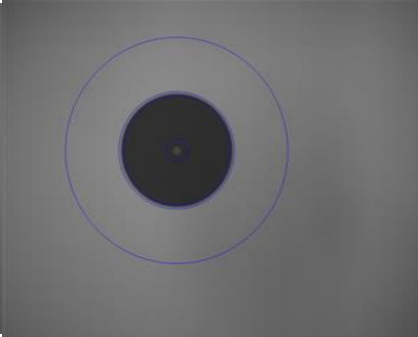
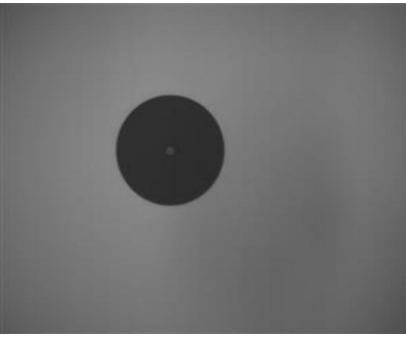
Zone Name	Diameter		Result	Defects		Scratches	
	Inner	Outer		Count	Area (μ2)	Result	Count
Zone A	0	25	PASS	0	0	PASS	0
Zone B	25	120	PASS	0	0	PASS	0
Zone C	120	130	PASS	0	0	PASS	0
Zone D	130	250	PASS	0	0	PASS	0
Zone E	250	1000	PASS	0	0	PASS	0
Epoxy Gap:	PASS	Fiber Type:	Simplex	Core Size:	9		
LOW Magnification				High Magnification

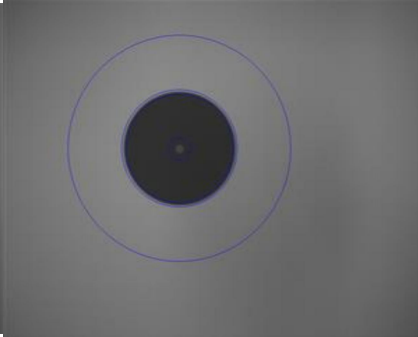
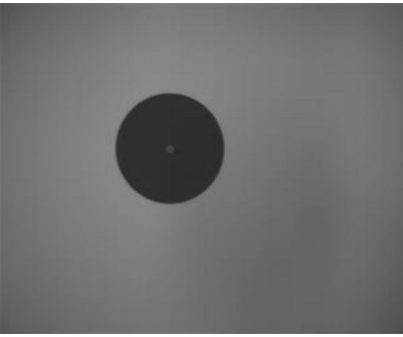
File Name: S26940-192600009B

Zone Name	Diameter		Result	Defects		Scratches	
	Inner	Outer		Count	Area (μ2)	Result	Count
Zone A	0	25	PASS	0	0	PASS	0
Zone B	25	120	PASS	0	0	PASS	0
Zone C	120	130	PASS	0	0	PASS	0
Zone D	130	250	PASS	0	0	PASS	0
Zone E	250	1000	PASS	0	0	PASS	0
Epoxy Gap:	PASS	Fiber Type:	Simplex	Core Size:	9		
LOW Magnification				High Magnification

****PASS****
