VISUAL INSPECTION SUMMARY REPORT

Optronics S.A. de C.V.

EQ R LINEA 2

File Name: S26940-192600007A

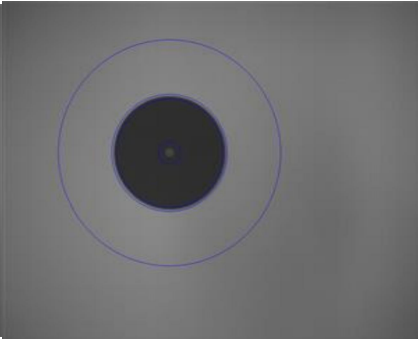
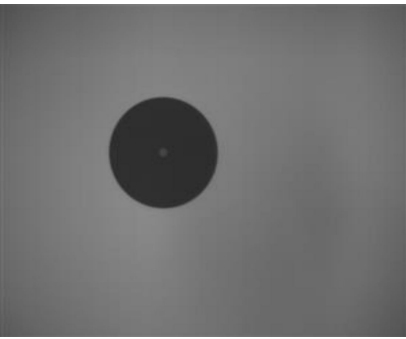
Profile: SM,Post Polish (IEC-61300-3-35 Table 4)

Zone Name	Diameter		Result	Defects		Scratches	
	Inner	Outer		Count	Area (μ2)	Result	Count
Zone A	0	25	PASS	0	0	PASS	0
Zone B	25	120	PASS	0	0	PASS	0
Zone C	120	130	PASS	0	0	PASS	0
Zone D	130	250	PASS	0	0	PASS	0
Zone E	250	1000	PASS	0	0	PASS	0
Epoxy Gap:	PASS	Fiber Type:	Simplex	Core Size:	9		
LOW Magnification				High Magnification

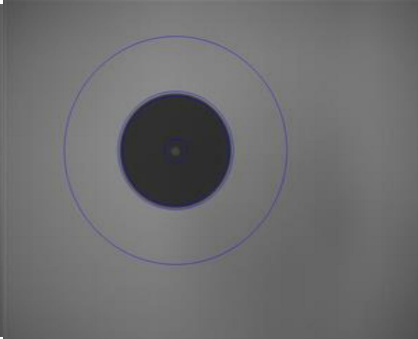
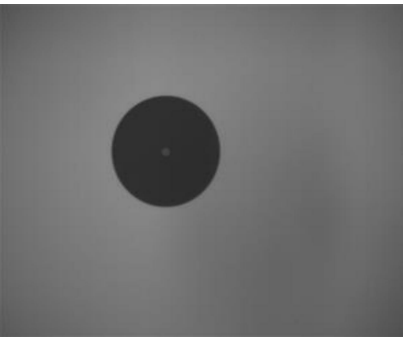
File Name: S26940-192600007B

Profile: SM,Post Polish (IEC-61300-3-35 Table 4)

Zone Name	Diameter		Result	Defects		Scratches	
	Inner	Outer		Count	Area (μ2)	Result	Count
Zone A	0	25	PASS	0	0	PASS	0
Zone B	25	120	PASS	0	0	PASS	0
Zone C	120	130	PASS	0	0	PASS	0
Zone D	130	250	PASS	0	0	PASS	0
Zone E	250	1000	PASS	0	0	PASS	0
Epoxy Gap:	PASS	Fiber Type:	Simplex	Core Size:	9		
LOW Magnification				High Magnification

****PASS****
