VISUAL INSPECTION SUMMARY REPORT

Optronics S.A. de C.V.

EQ R LINEA 2

File Name: S26940-192600002A

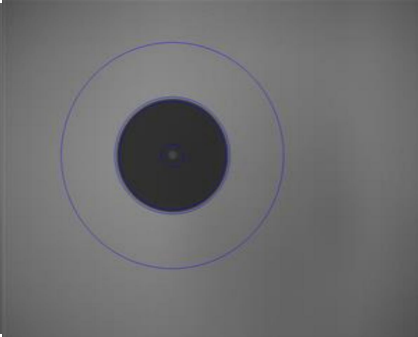
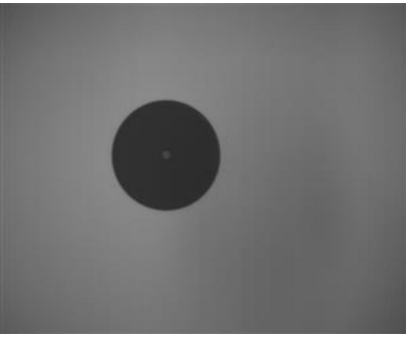
Zone Name	Diameter		Result	Defects		Scratches	
	Inner	Outer		Count	Area (μ2)	Result	Count
Zone A	0	25	PASS	0	0	PASS	0
Zone B	25	120	PASS	0	0	PASS	0
Zone C	120	130	PASS	0	0	PASS	0
Zone D	130	250	PASS	0	0	PASS	0
Zone E	250	1000	PASS	0	0	PASS	0
Epoxy Gap:	PASS	Fiber Type:	Simplex	Core Size:	9		
LOW Magnification				High Magnification

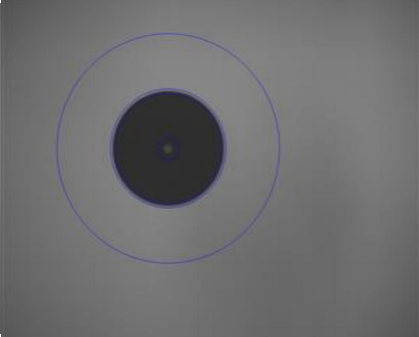
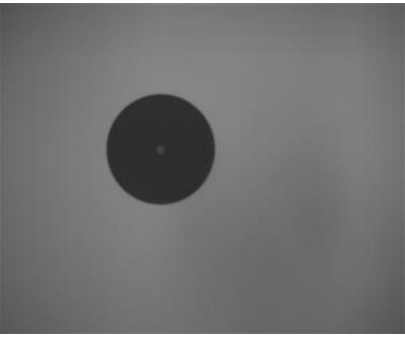
File Name: S26940-192600002B

Zone Name	Diameter		Result	Defects		Scratches	
	Inner	Outer		Count	Area (μ2)	Result	Count
Zone A	0	25	PASS	0	0	PASS	0
Zone B	25	120	PASS	0	0	PASS	0
Zone C	120	130	PASS	0	0	PASS	0
Zone D	130	250	PASS	0	0	PASS	0
Zone E	250	1000	PASS	0	0	PASS	0
Epoxy Gap:	PASS	Fiber Type:	Simplex	Core Size:	9		
LOW Magnification				High Magnification

****PASS****
