VISUAL INSPECTION SUMMARY REPORT

Optronics S.A. de C.V.

File Name: S26940-192600004A

Serial Number: S26940-192600004

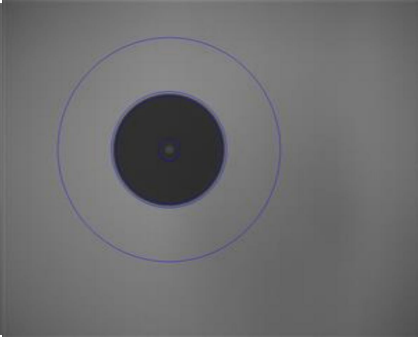
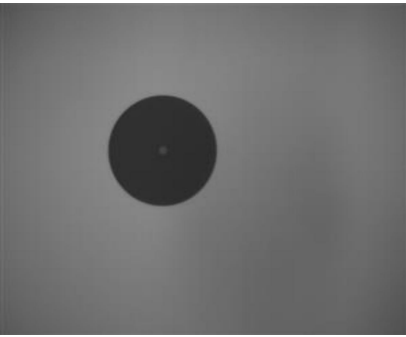
Zone Name	Diameter		Result	Defects		Scratches	
	Inner	Outer		Count	Area (μ2)	Result	Count
Zone A	0	25	PASS	0	0	PASS	0
Zone B	25	120	PASS	0	0	PASS	0
Zone C	120	130	PASS	0	0	PASS	0
Zone D	130	250	PASS	0	0	PASS	0
Zone E	250	1000	PASS	0	0	PASS	0
Epoxy Gap:	PASS	Fiber Type:	Simplex	Core Size:	9		
LOW Magnification				High Magnification

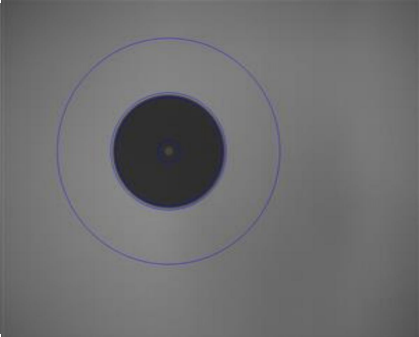
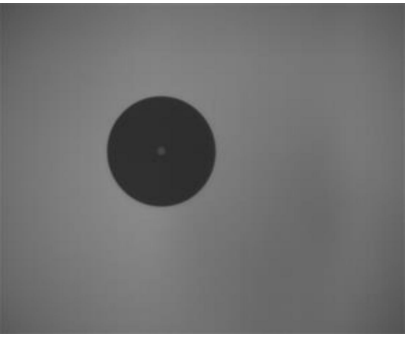
File Name: S26940-192600004B

Zone Name	Diameter		Result	Defects		Scratches	
	Inner	Outer		Count	Area (μ2)	Result	Count
Zone A	0	25	PASS	0	0	PASS	0
Zone B	25	120	PASS	0	0	PASS	0
Zone C	120	130	PASS	0	0	PASS	0
Zone D	130	250	PASS	0	0	PASS	0
Zone E	250	1000	PASS	0	0	PASS	0
Epoxy Gap:	PASS	Fiber Type:	Simplex	Core Size:	9		
LOW Magnification				High Magnification

****PASS****
