VISUAL INSPECTION SUMMARY REPORT

Optronics S.A. de C.V.

File Name: S26940-192600010A

Serial Number: S26940-192600010

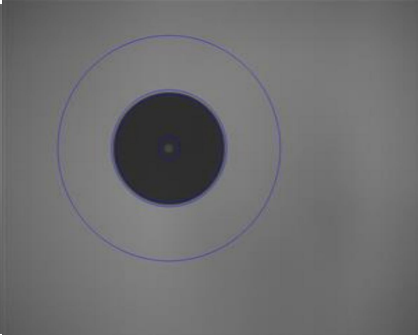
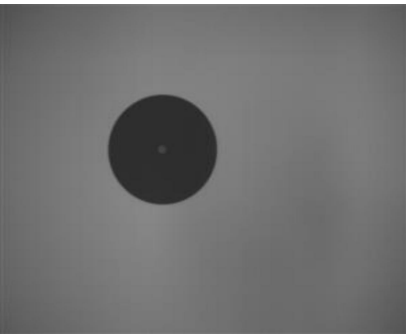
Zone Name	Diameter		Result	Defects		Scratches	
	Inner	Outer		Count	Area (μ2)	Result	Count
Zone A	0	25	PASS	0	0	PASS	0
Zone B	25	120	PASS	0	0	PASS	0
Zone C	120	130	PASS	0	0	PASS	0
Zone D	130	250	PASS	0	0	PASS	0
Zone E	250	1000	PASS	0	0	PASS	0
Epoxy Gap:	PASS	Fiber Type:	Simplex	Core Size:	9		
LOW Magnification				High Magnification
