VISUAL INSPECTION SUMMARY REPORT

Optronics S.A. de C.V.

EQ R LINEA 2

File Name: S26940-192600005A

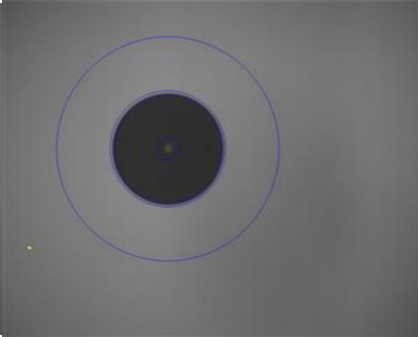
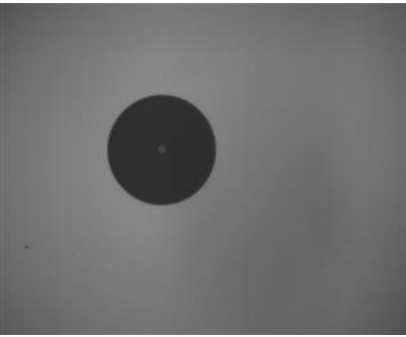
Zone Name	Diameter		Result	Defects		Scratches	
	Inner	Outer		Count	Area (μ2)	Result	Count
Zone A	0	25	PASS	0	0	PASS	0
Zone B	25	120	PASS	0	0	PASS	0
Zone C	120	130	PASS	0	0	PASS	0
Zone D	130	250	PASS	0	0	PASS	0
Zone E	250	1000	PASS	1	0	PASS	0
Epoxy Gap:	PASS	Fiber Type:	Simplex	Core Size:	9		
LOW Magnification				High Magnification

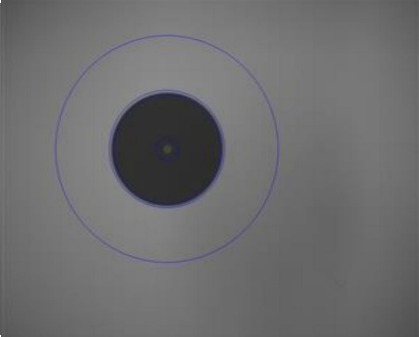
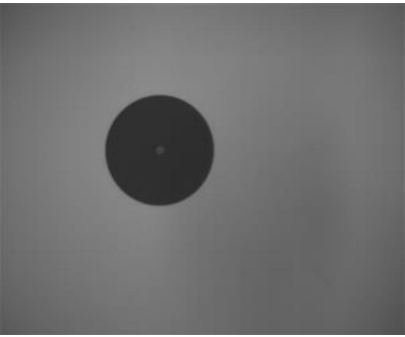
File Name: S26940-192600005B

Zone Name	Diameter		Result	Defects		Scratches	
	Inner	Outer		Count	Area (μ2)	Result	Count
Zone A	0	25	PASS	0	0	PASS	0
Zone B	25	120	PASS	0	0	PASS	0
Zone C	120	130	PASS	0	0	PASS	0
Zone D	130	250	PASS	0	0	PASS	0
Zone E	250	1000	PASS	0	0	PASS	0
Epoxy Gap:	PASS	Fiber Type:	Simplex	Core Size:	9		
LOW Magnification				High Magnification

****PASS****
