VISUAL INSPECTION SUMMARY REPORT

Optronics S.A. de C.V.

File Name: S26940-192600006A

Serial Number: S26940-192600006

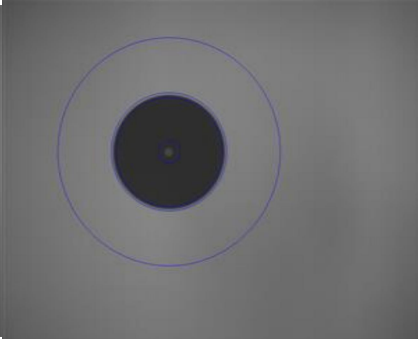
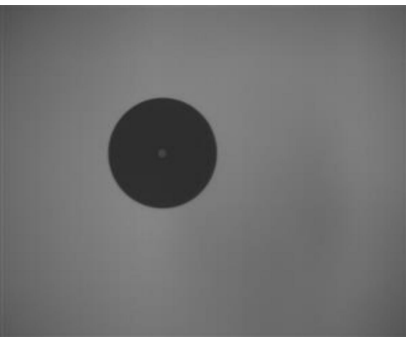
Zone Name	Diameter		Result	Defects		Scratches	
	Inner	Outer		Count	Area (μ2)	Result	Count
Zone A	0	25	PASS	0	0	PASS	0
Zone B	25	120	PASS	0	0	PASS	0
Zone C	120	130	PASS	0	0	PASS	0
Zone D	130	250	PASS	0	0	PASS	0
Zone E	250	1000	PASS	0	0	PASS	0
Epoxy Gap:	PASS	Fiber Type:	Simplex	Core Size:	9		
LOW Magnification				High Magnification

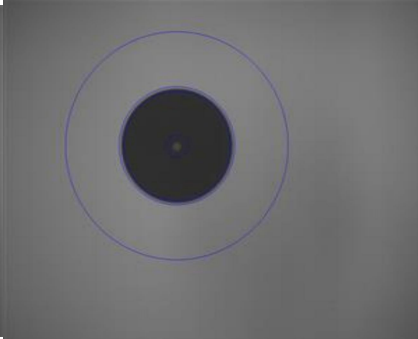
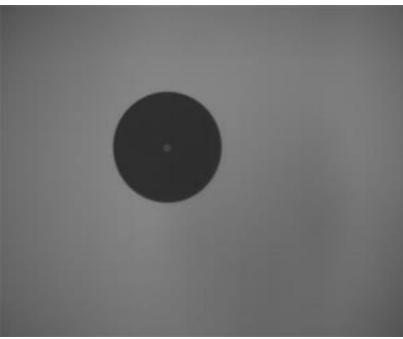
File Name: S26940-192600006B

Zone Name	Diameter		Result	Defects		Scratches	
	Inner	Outer		Count	Area (μ2)	Result	Count
Zone A	0	25	PASS	0	0	PASS	0
Zone B	25	120	PASS	0	0	PASS	0
Zone C	120	130	PASS	0	0	PASS	0
Zone D	130	250	PASS	0	0	PASS	0
Zone E	250	1000	PASS	0	0	PASS	0
Epoxy Gap:	PASS	Fiber Type:	Simplex	Core Size:	9		
LOW Magnification				High Magnification

****PASS****
