VISUAL INSPECTION SUMMARY REPORT

Optronics S.A. de C.V.

File Name: S26940-192600017A

Serial Number: S26940-192600017

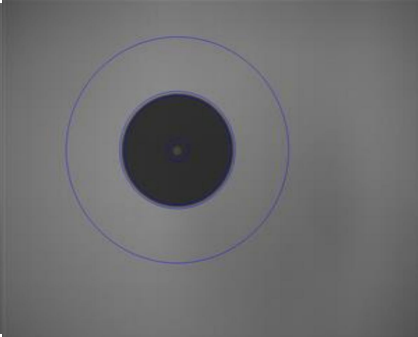
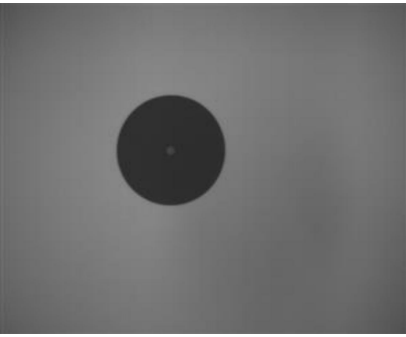
Zone Name	Diameter		Result	Defects		Scratches	
	Inner	Outer		Count	Area (μ2)	Result	Count
Zone A	0	25	PASS	0	0	PASS	0
Zone B	25	120	PASS	0	0	PASS	0
Zone C	120	130	PASS	0	0	PASS	0
Zone D	130	250	PASS	0	0	PASS	0
Zone E	250	1000	PASS	0	0	PASS	0
Epoxy Gap:	PASS	Fiber Type:	Simplex	Core Size:	9		
LOW Magnification				High Magnification

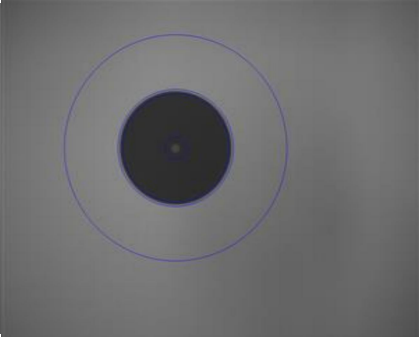
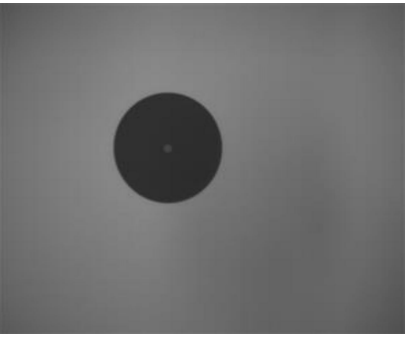
File Name: S26940-192600017B

Zone Name	Diameter		Result	Defects		Scratches	
	Inner	Outer		Count	Area (μ2)	Result	Count
Zone A	0	25	PASS	0	0	PASS	0
Zone B	25	120	PASS	0	0	PASS	0
Zone C	120	130	PASS	0	0	PASS	0
Zone D	130	250	PASS	0	0	PASS	0
Zone E	250	1000	PASS	0	0	PASS	0
Epoxy Gap:	PASS	Fiber Type:	Simplex	Core Size:	9		
LOW Magnification				High Magnification

****PASS****
