VISUAL INSPECTION SUMMARY REPORT

Optronics S.A. de C.V.

EQ R LINEA 2

File Name: S26940-192600008A

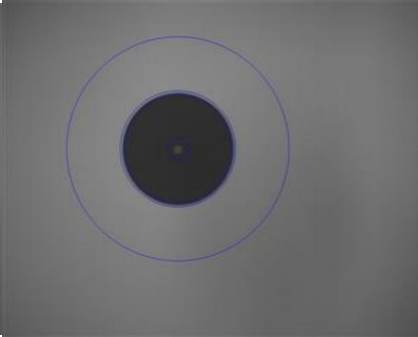
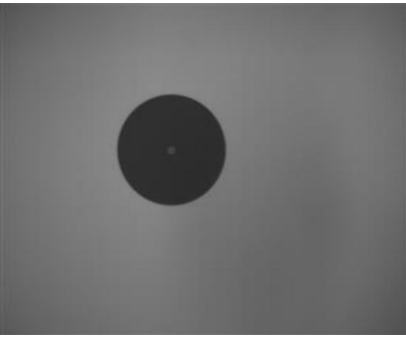
Zone Name	Diameter		Result	Defects		Scratches	
	Inner	Outer		Count	Area (μ2)	Result	Count
Zone A	0	25	PASS	0	0	PASS	0
Zone B	25	120	PASS	0	0	PASS	0
Zone C	120	130	PASS	0	0	PASS	0
Zone D	130	250	PASS	0	0	PASS	0
Zone E	250	1000	PASS	0	0	PASS	0
Epoxy Gap:	PASS	Fiber Type:	Simplex	Core Size:	9		
LOW Magnification				High Magnification

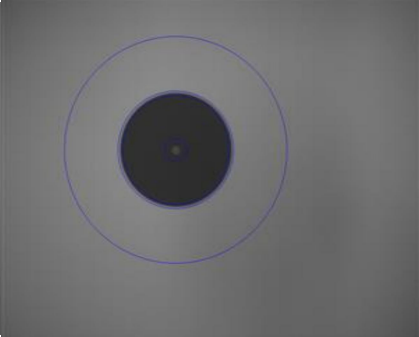
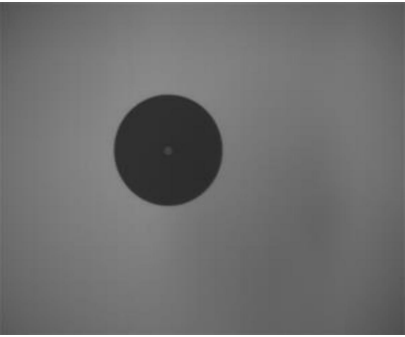
File Name: S26940-192600008B

Zone Name	Diameter		Result	Defects		Scratches	
	Inner	Outer		Count	Area (μ2)	Result	Count
Zone A	0	25	PASS	0	0	PASS	0
Zone B	25	120	PASS	0	0	PASS	0
Zone C	120	130	PASS	0	0	PASS	0
Zone D	130	250	PASS	0	0	PASS	0
Zone E	250	1000	PASS	0	0	PASS	0
Epoxy Gap:	PASS	Fiber Type:	Simplex	Core Size:	9		
LOW Magnification				High Magnification

****PASS****
