VISUAL INSPECTION SUMMARY REPORT

Optronics S.A. de C.V.

EQ R LINEA 2

File Name: S26940-192600018A

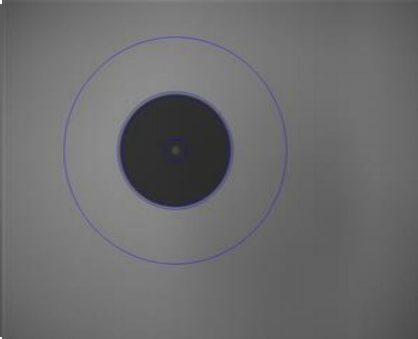
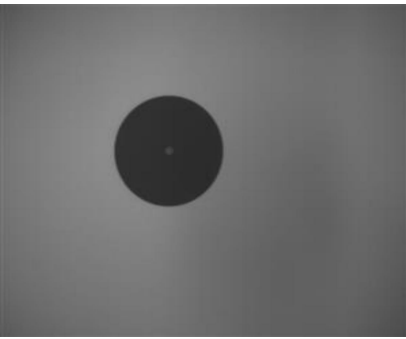
Zone Name	Diameter		Result	Defects		Scratches	
	Inner	Outer		Count	Area (μ2)	Result	Count
Zone A	0	25	PASS	0	0	PASS	0
Zone B	25	120	PASS	0	0	PASS	0
Zone C	120	130	PASS	0	0	PASS	0
Zone D	130	250	PASS	0	0	PASS	0
Zone E	250	1000	PASS	0	0	PASS	0
Epoxy Gap:	PASS	Fiber Type:	Simplex	Core Size:	9		
LOW Magnification				High Magnification

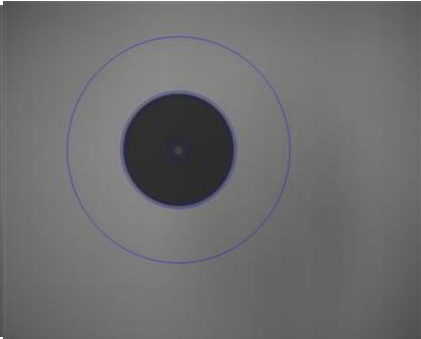
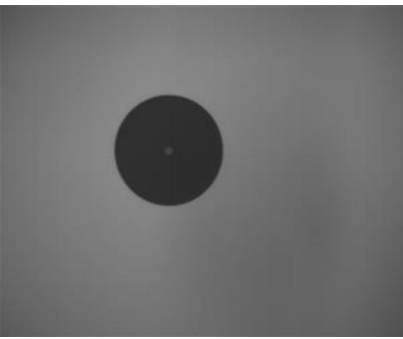
File Name: S26940-192600018B

Zone Name	Diameter		Result	Defects		Scratches	
	Inner	Outer		Count	Area (μ2)	Result	Count
Zone A	0	25	PASS	0	0	PASS	0
Zone B	25	120	PASS	0	0	PASS	0
Zone C	120	130	PASS	0	0	PASS	0
Zone D	130	250	PASS	0	0	PASS	0
Zone E	250	1000	PASS	0	0	PASS	0
Epoxy Gap:	PASS	Fiber Type:	Simplex	Core Size:	9		
LOW Magnification				High Magnification

****PASS****
