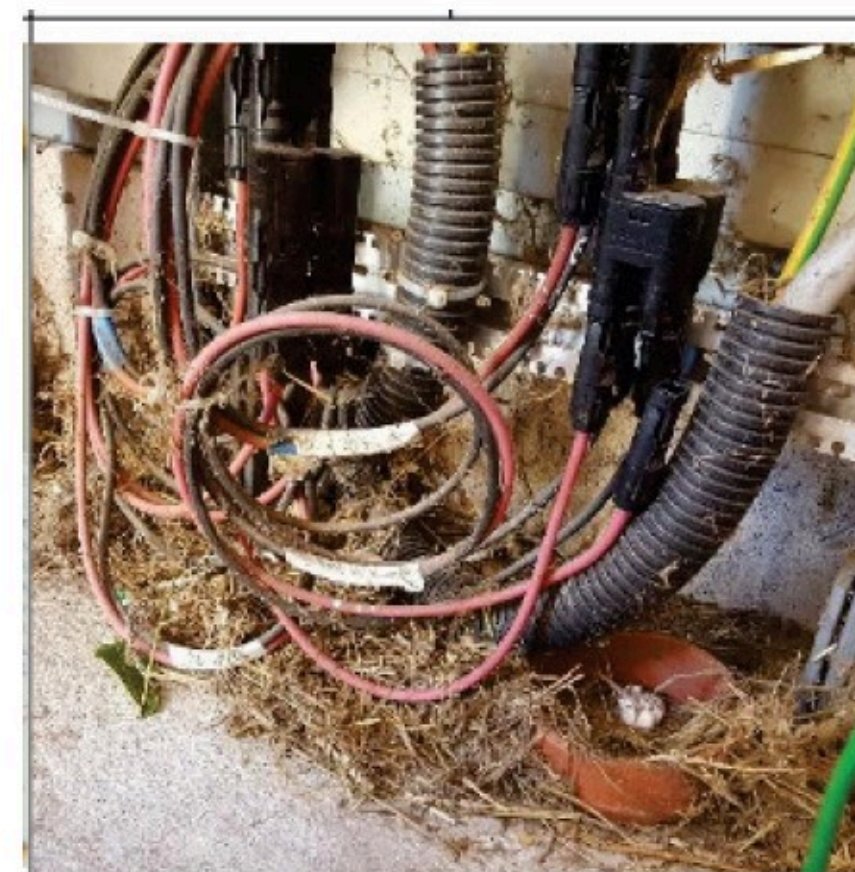
Distance to bottom, top or to the
sides too low [By courtesy of
TUV Rheinland].

Presence of inflammable mate-
rial [By courtesy of SUPSI
PVLab].
