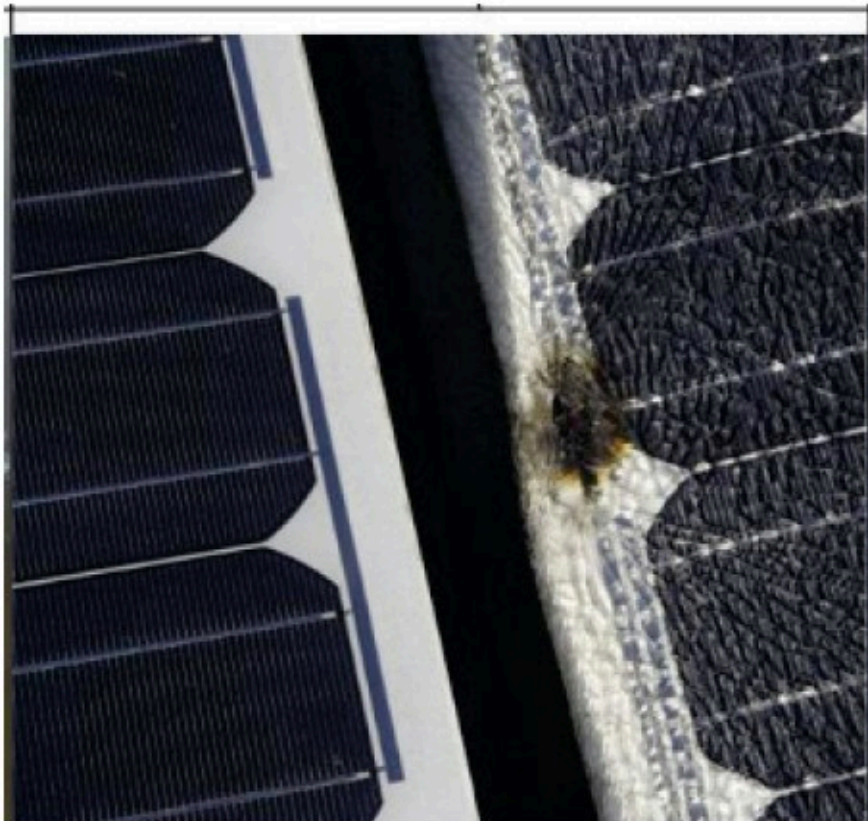
Glass breakage of tempered glass induced by burn mark [Köntges17]. (see also PVFS 1-7 and PVFS 1-9)

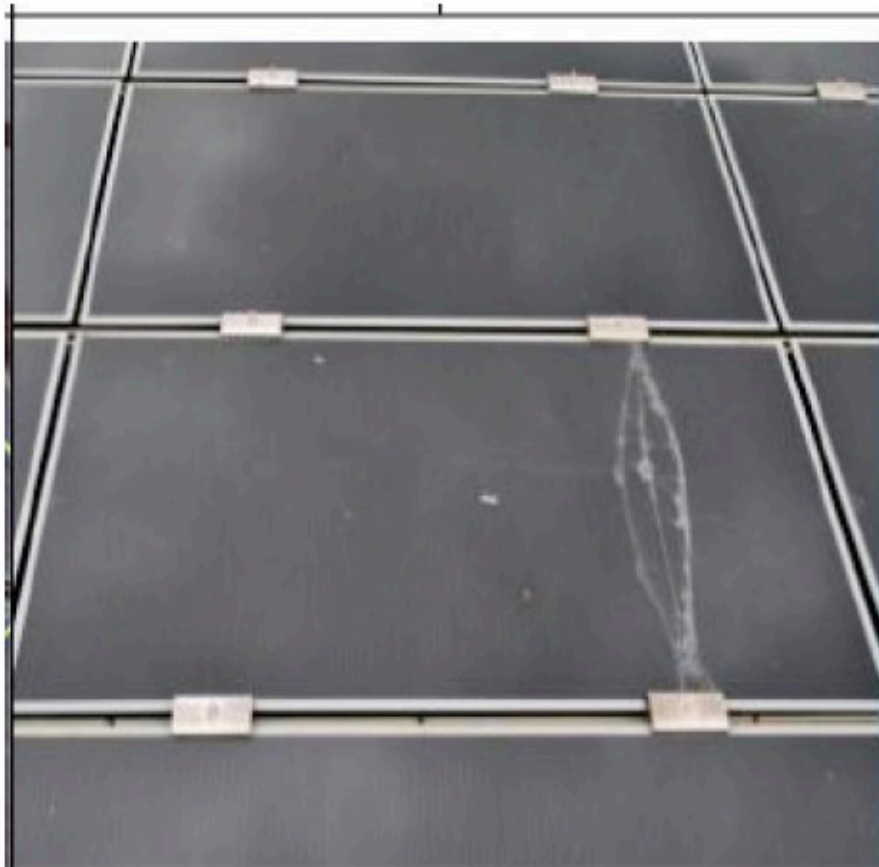
Glass breakage caused due to poor clamp design [Köntges17]. (see also PVFS 3-1)
