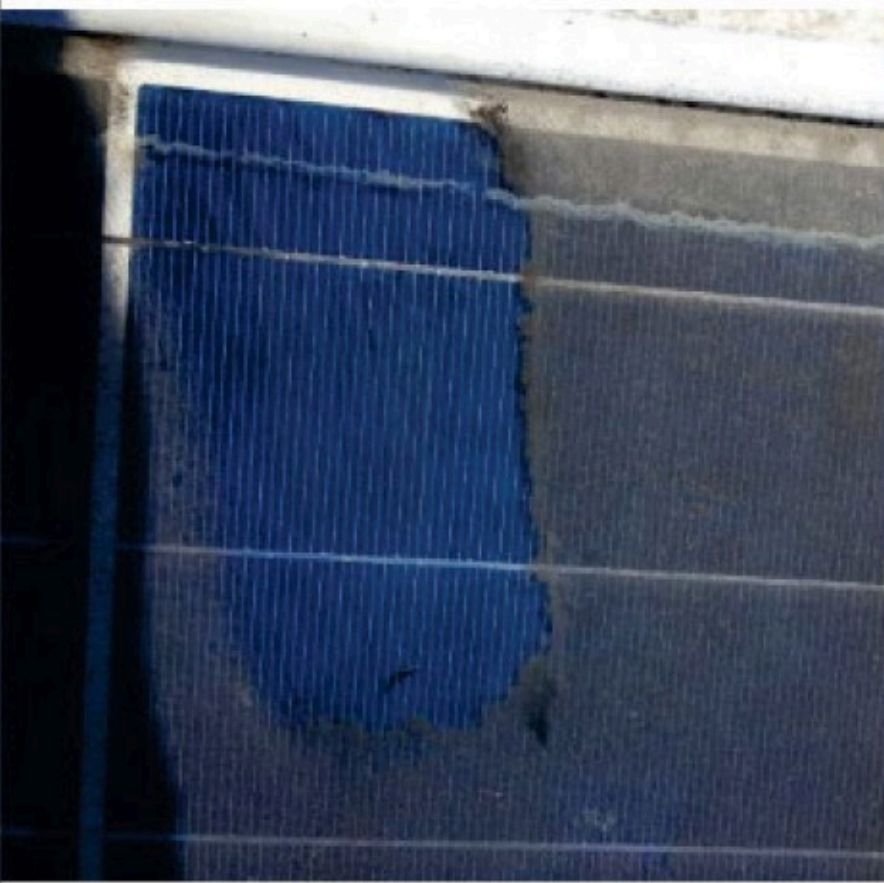
Uniform light soiling, which in ideal conditions is self-cleaning when raining [By the courtesy of SUPSI PVLab].

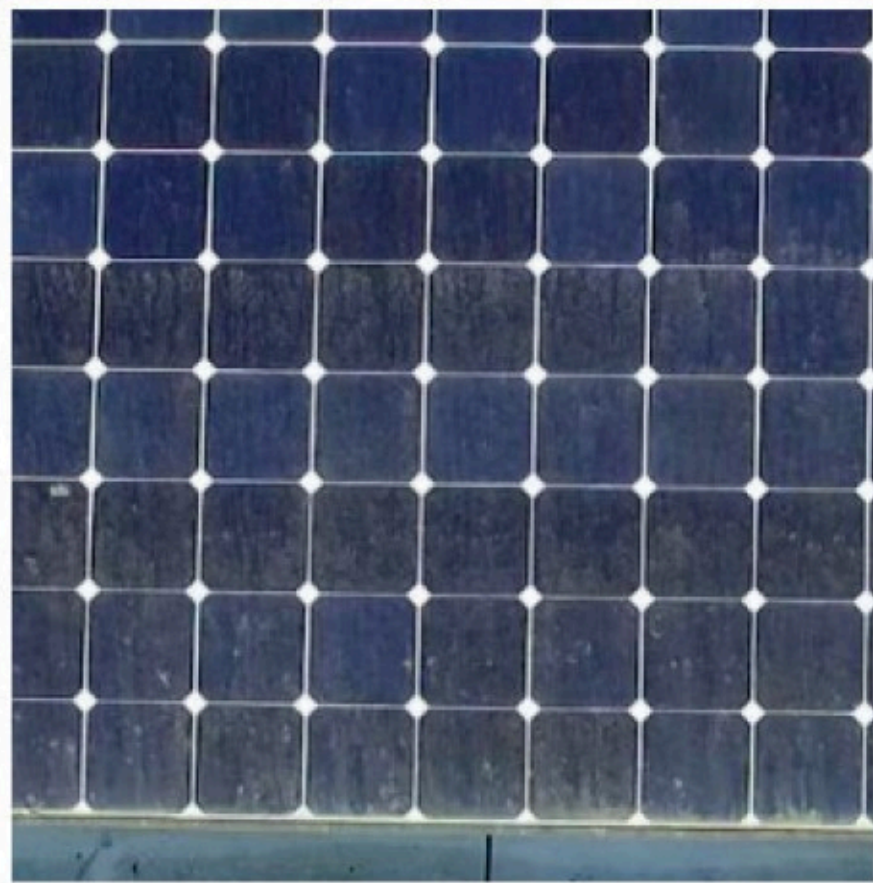
Uniform heavy soiling caused by rail way station [By the courtesy of SUPSI PVLab].
